Existing Steel Framing Section View

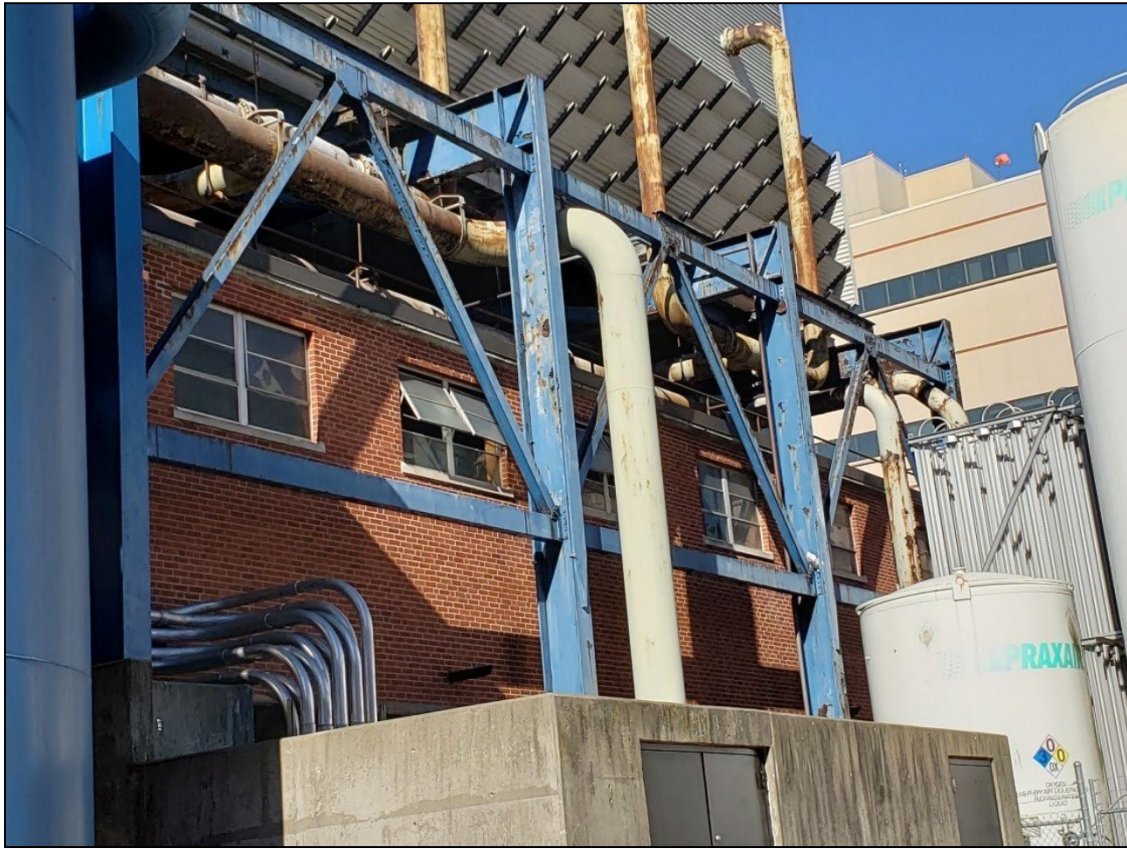
*Photo 001 Overview of Northeast Face of Structure
Rust and spalling paint were observed at the four exposed columns and vertical lateral
braces. They mainly occurred on the face of the column webs and brace flanges.*

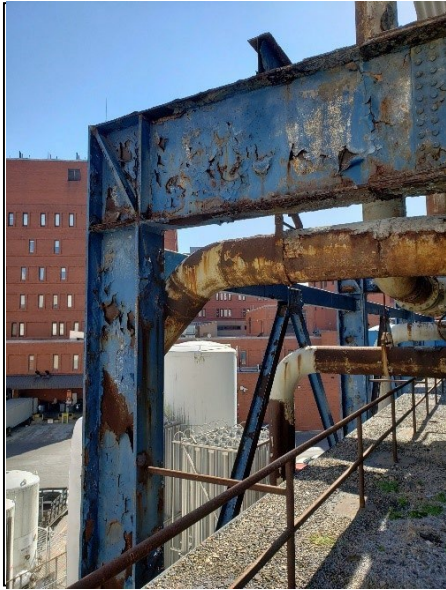
Photo 002

At the column to girder connection, paint peeled off from the member webs. The girder flanges and column stiffener plates were delaminated.

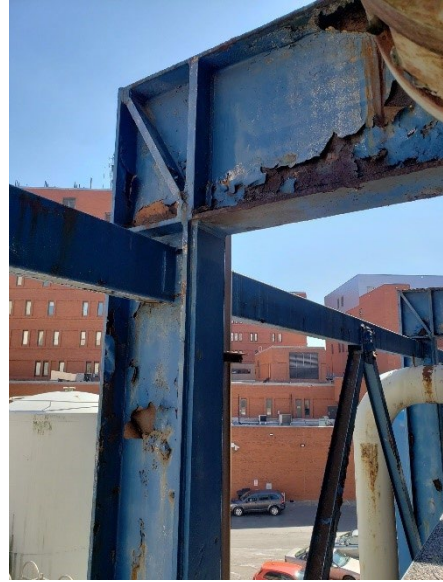
Photo 003

At the column to girder connection, paint peeled off from the member webs. The girder flanges and column stiffener plates were delaminated.

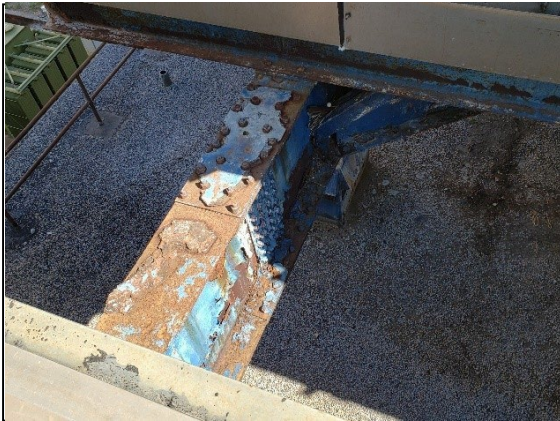
Photo 004

At the column to girder connection where the girder entered the existing building, girder flanges were delaminated.

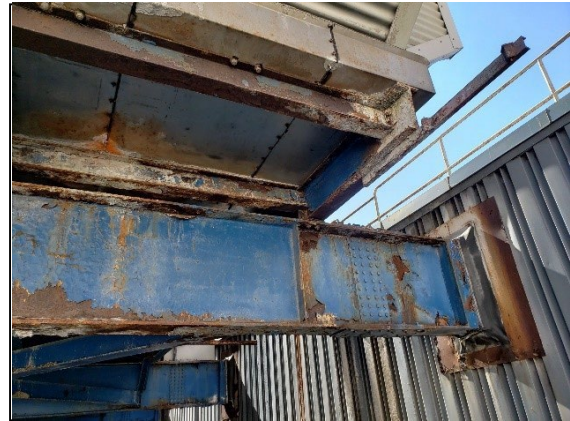
Photo 005

Along the northwest face of the structure, both primary framing and minor framing corroded severely. The flanges of girder were delaminated.

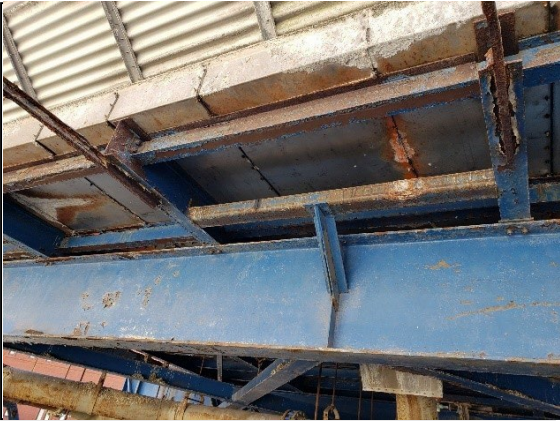
Photo 006

Along the northwest face of the structure, the minor framing corroded severely.

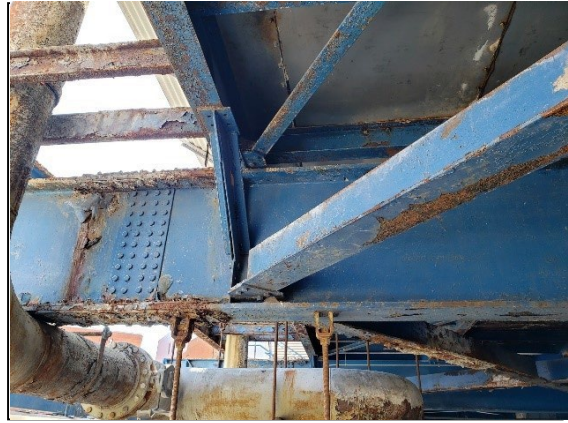
Photo 007

Along the northeast face of the structure, the channels bracing pipes corroded severely.

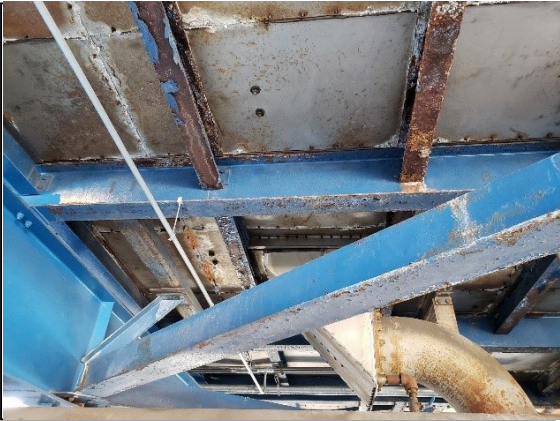
Photo 008

The minor framing below the cooling tower pan corroded severely.

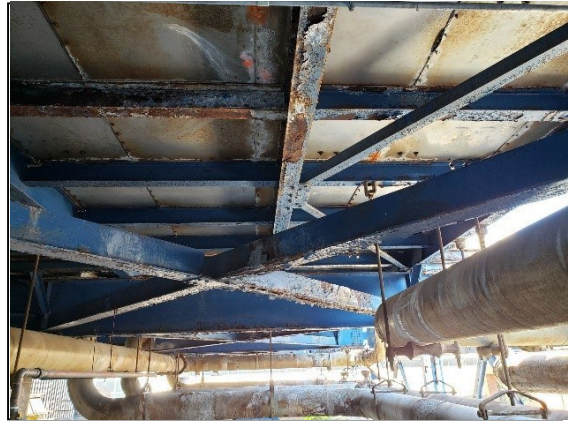
Photo 009

The minor framing below the cooling tower pan corroded severely.

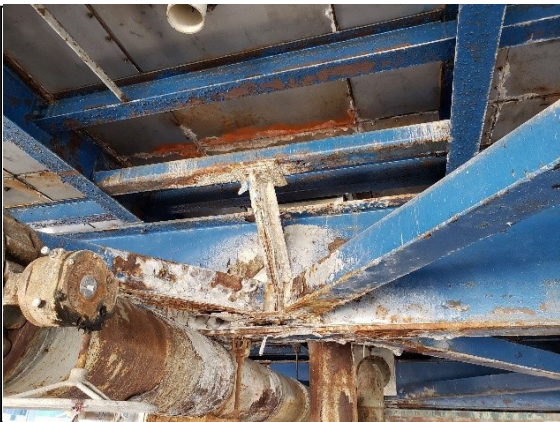
Photo 010

The primary framing, including steel girders and braces, corroded severely below the cooling tower pan where water leaked.

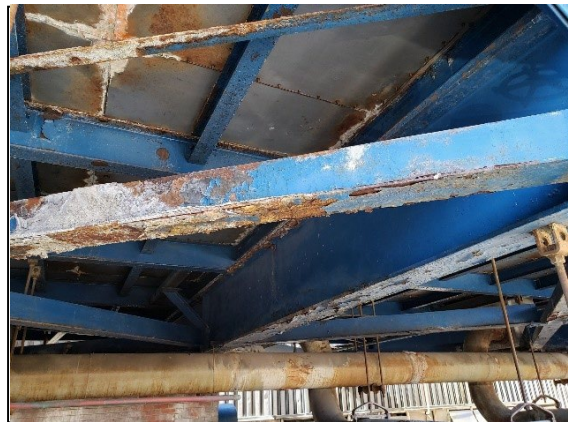
Photo 011

Both primary framing and minor framing braces corroded where water leaked from the cooling pan above.
