CM SERVICES – SCOVELL HALL RENOVATION

ADDENDUM #1

# **ASBESTOS CONTAINING MATERIALS, POLYCHLORINATED BIPHENYLS IN CAULK, LEAD-BASED PAINT, & HAZARDOUS MATERIALS INSPECTION REPORT**

**University of Kentucky - Scovell Hall  
115 Huguelet Drive  
Lexington, Fayette County, Kentucky 40508**

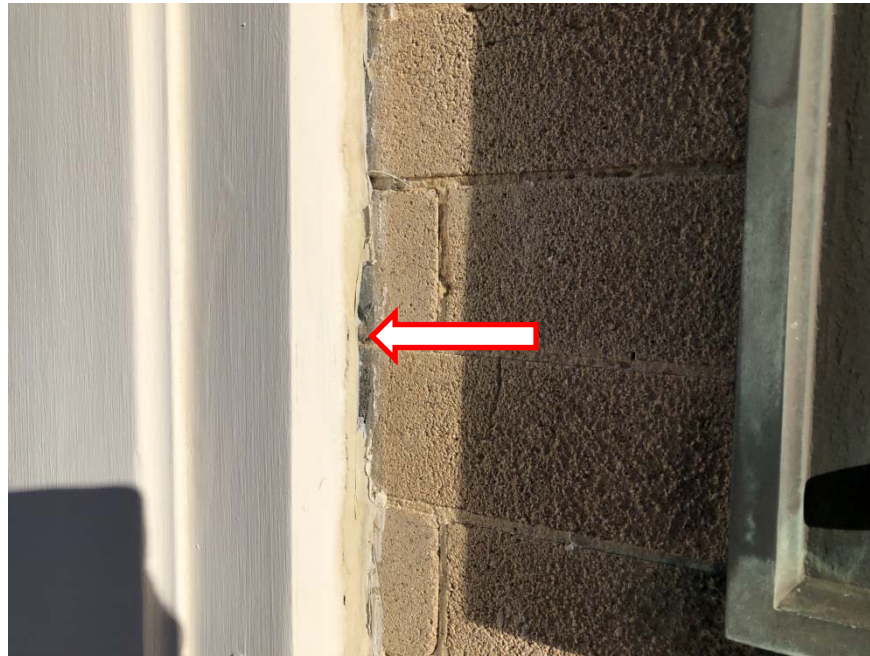
| 11 | DESCRIPTION | View of the PCB containing door frame caulk located on the Side A entry door of Section 1. Sample # PA-01A |

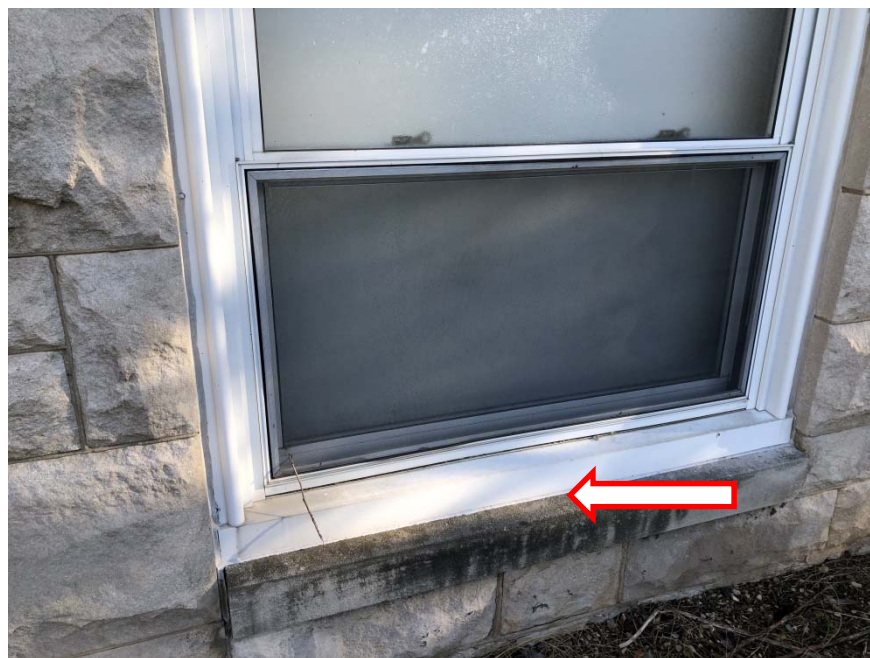
| 12 | DESCRIPTION | View of the PCB containing metal window caulk located on Side A of Section 1. Sample # PA-02A |

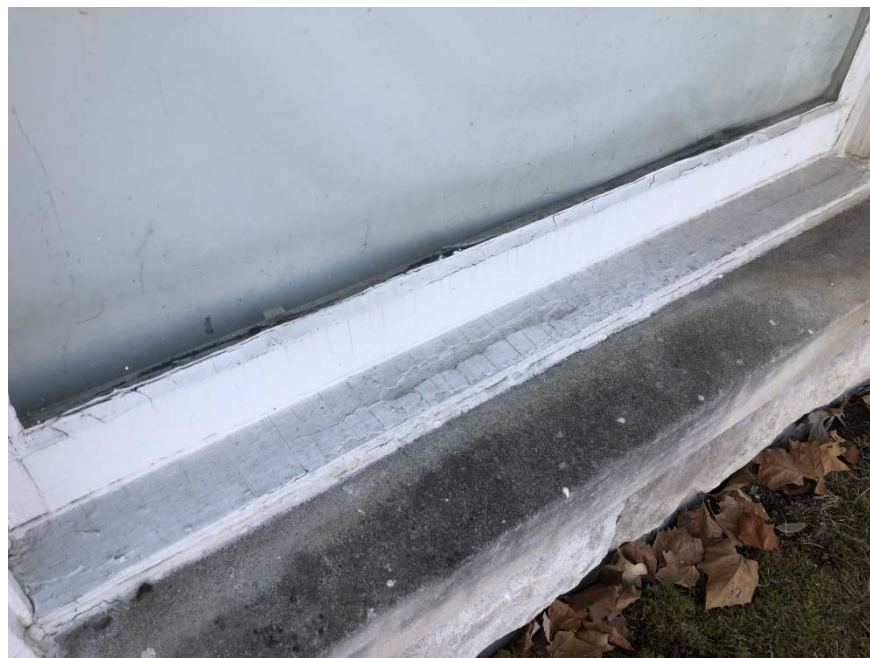
| 14 | DESCRIPTION | View of a wooden window located on Side B of Section 1 showing the positive lead-based paint, asbestos window putty, and PCB caulking. |

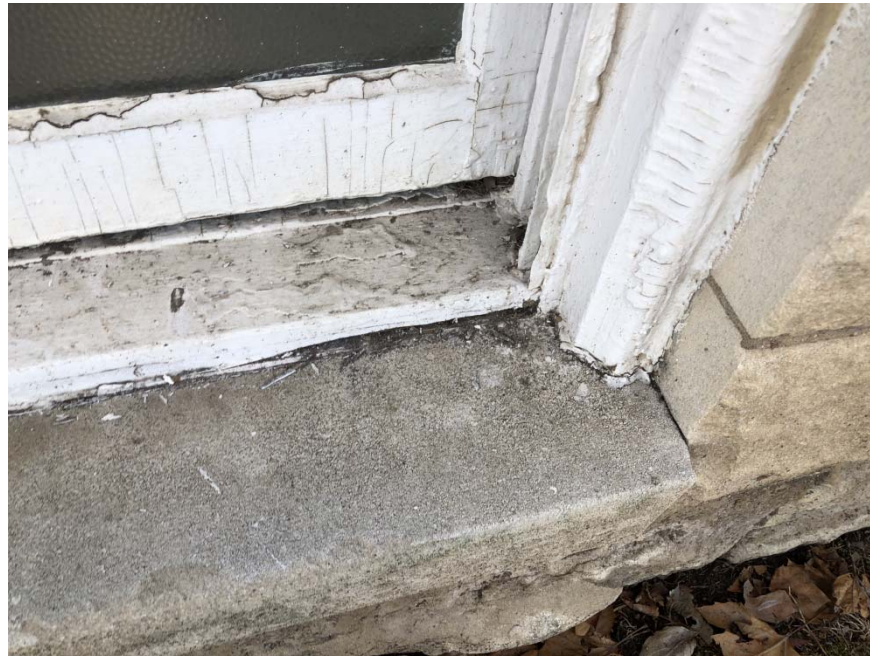
| 15 | DESCRIPTION | View of a wooden window located on Side B of Section 2 showing the positive lead-based paint, asbestos window putty, and PCB caulking. |

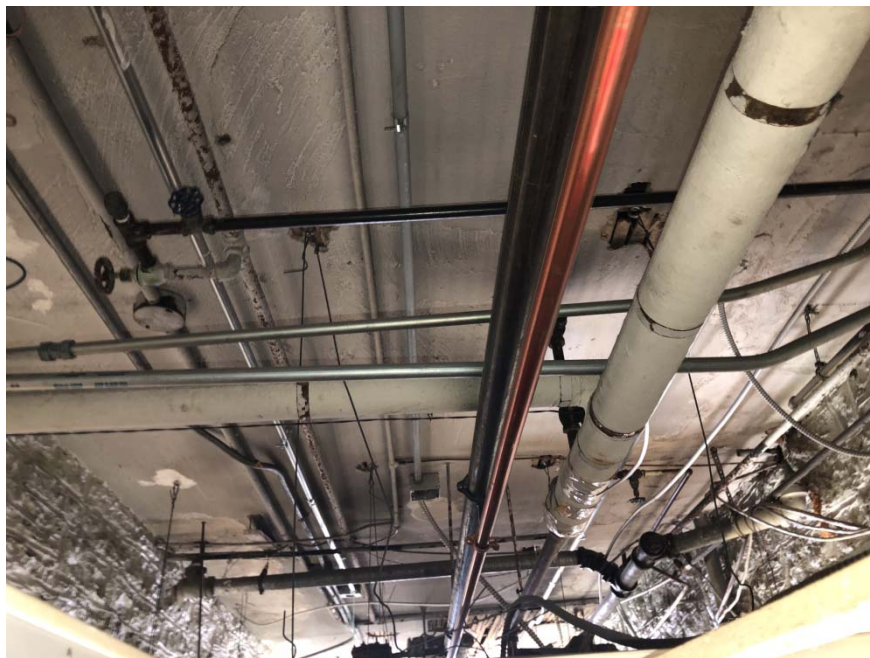
- Asbestos was historically found within the Thermal System Insulation (TSI) associated with the pipe elbows, tees, hangers, valves, and straight runs (exposed and within walls and ceilings) throughout Section 1 of the subject building in addition to the aforementioned mechanical room. All associated TSI is in friable condition and considered RACM.

| 20 | DESCRIPTION | View of the asbestos containing TSI and fittings located above the suspended ceiling within the basement of Section 1. |

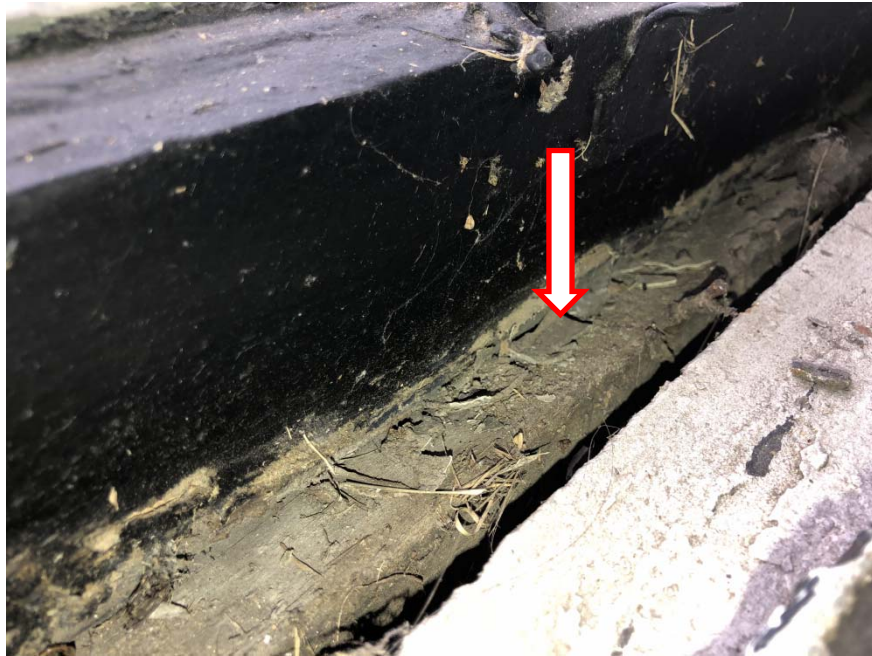
| 21 | DESCRIPTION | View of the asbestos containing wooden window frame caulk located within the basement of Section 1. |

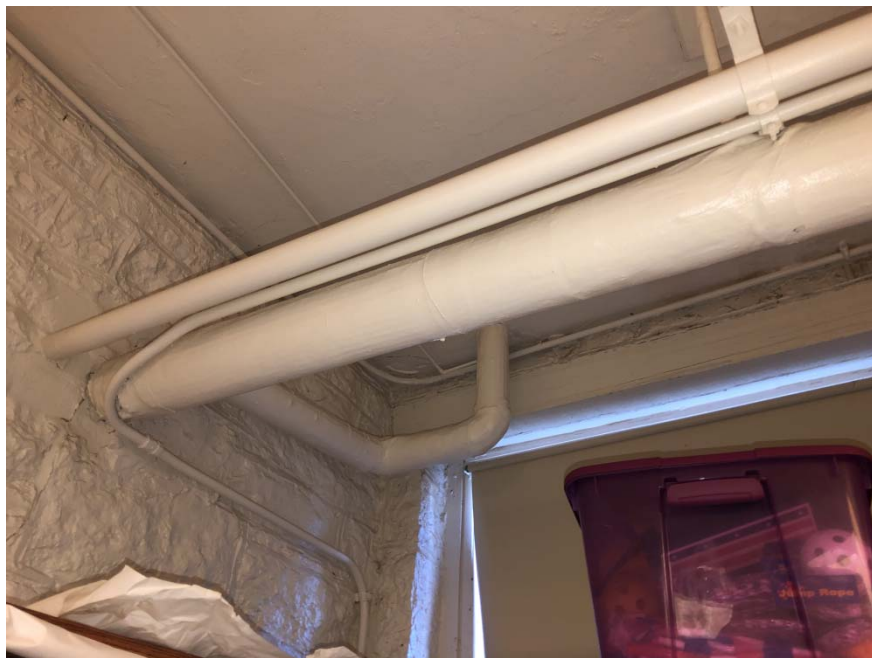
- Asbestos is present within the white fibrous firestop material located at various wall pipe penetrations throughout Section 1 of the subject building. All associated firestop is in friable condition and considered RACM.

| 22 | DESCRIPTION | Interior view of 'Room 11' within the basement of Section 1 showing the asbestos containing TSI, fittings, and pipe penetration firestop. |

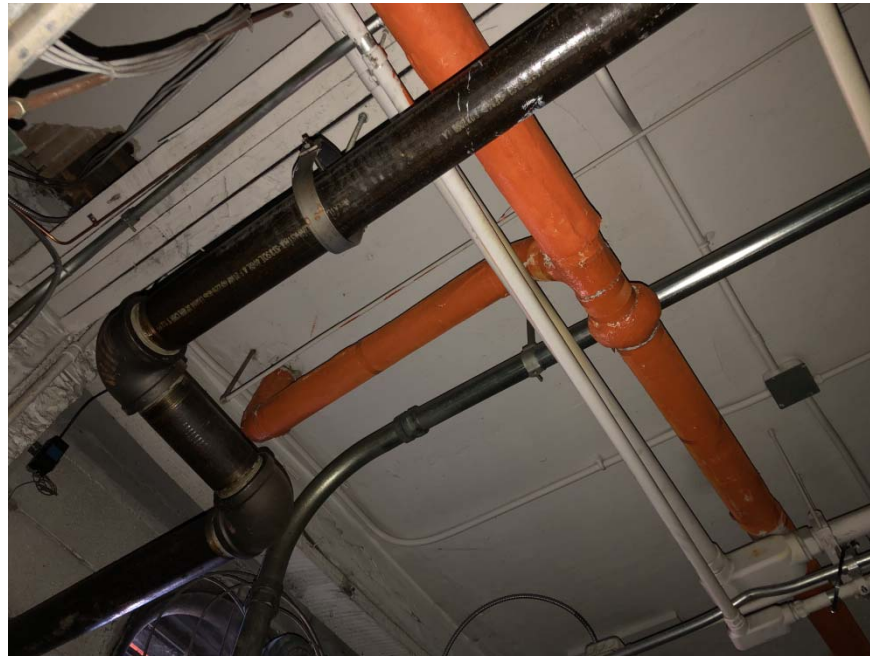
- Asbestos was historically found within the Thermal System Insulation (TSI) associated with various expansion tank(s), pipe elbows, tees, hangers, valves, and/or straight runs within Room 12 (Mechanical) located within the basement of Section 1. All associated TSI is in friable condition and considered RACM.

| 25 | DESCRIPTION | View of the asbestos containing TSI and fittings located within the basement of Section 1 (Room 12 – Mechanical). |

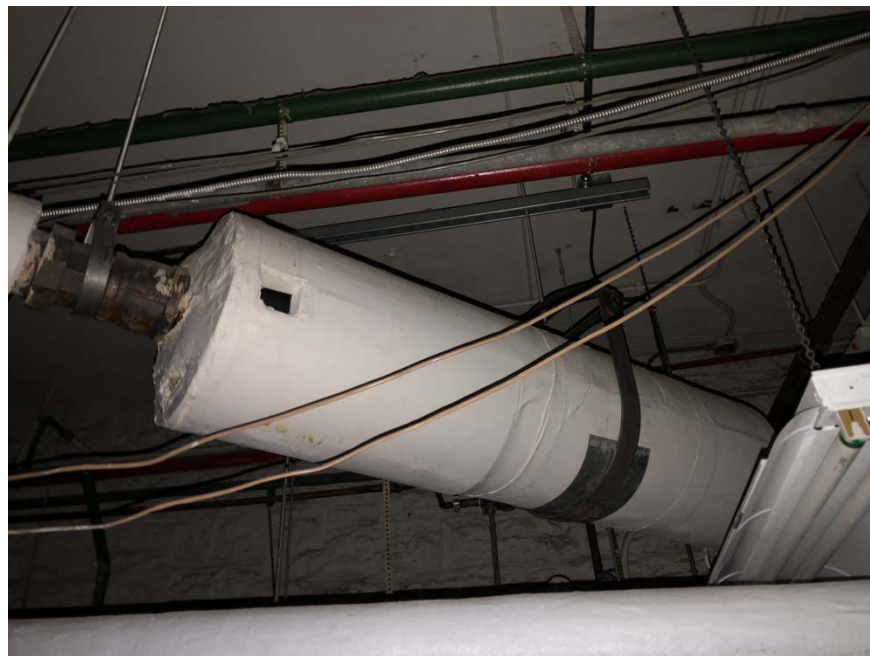
| 26 | DESCRIPTION | View of the asbestos containing TSI located on the expansion tank within the basement of Section 1 (Room 12 – Mechanical). |

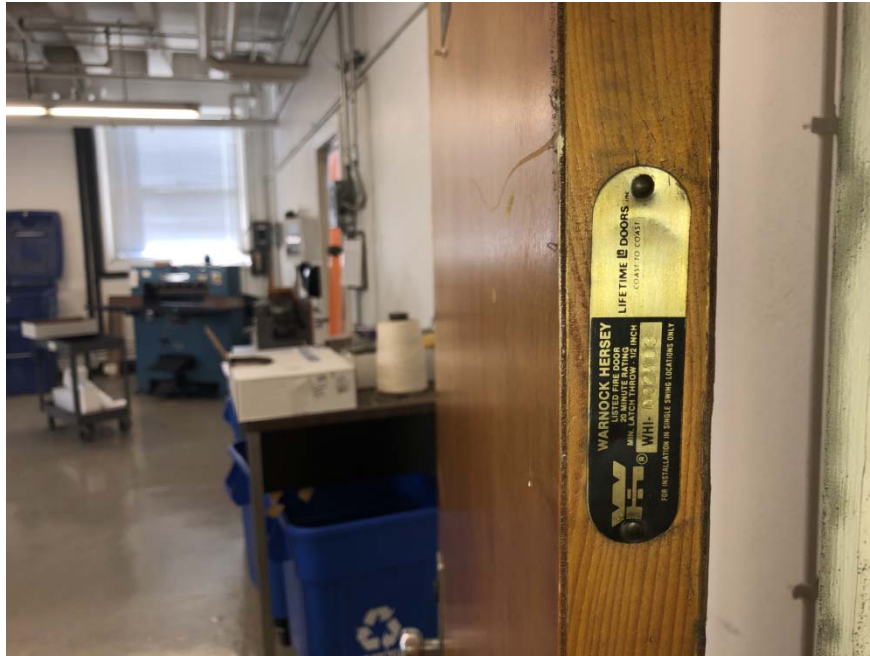
- Asbestos is assumed present within the insulation of various fire doors throughout Section 1 of the subject building. Due to the non-destructive nature of the sampling activities, access to the interior insulating core was prevented; therefore results are based on our experience with similarly aged structures and historically positive results. All associated insulating core material is in friable condition and is considered RACM.

| 35 | DESCRIPTION | Example view of a suspect asbestos containing fire door located within the subject building. |

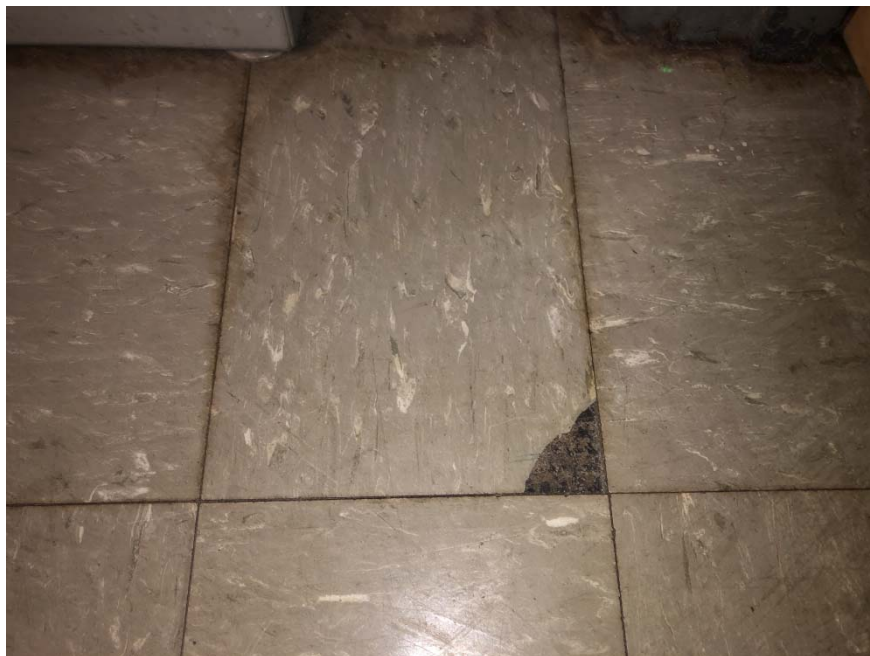
- Asbestos is present in various 12x12" floor tiles and the associated black mastic (exposed and/or below finished flooring) within hallways, offices, vaults, closets, etc. throughout the interior of Section 3. All associated floor tile and mastic are in non-friable condition and considered a Category I non-friable material. If renovation/demolition activities are performed in accordance with the NESHAP regulations, this material is not considered RACM.

| 36 | DESCRIPTION | View of the asbestos containing gray 12x12" VCT and associated black mastic located within the basement of Section 3. |

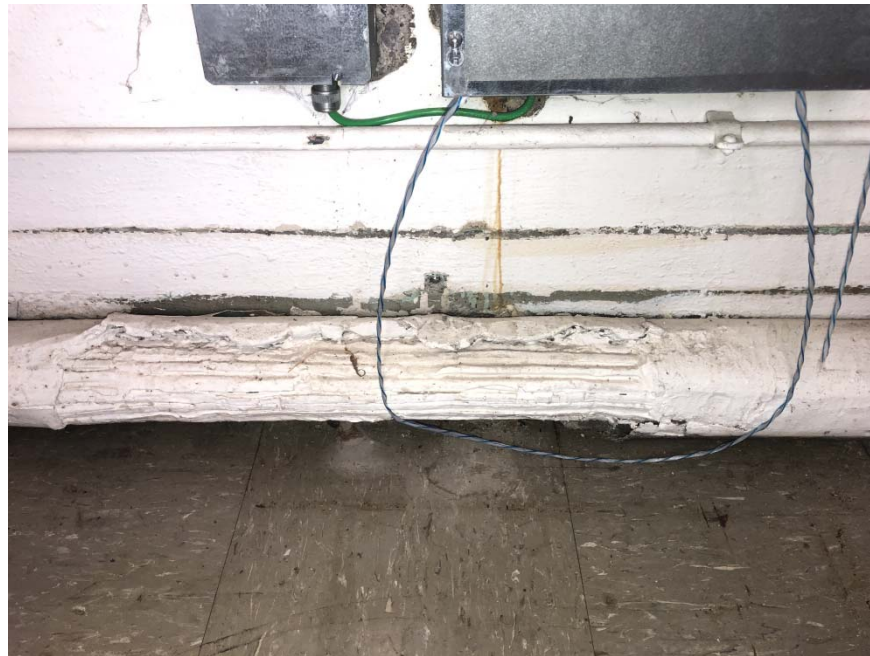
| 37 | DESCRIPTION | View of the asbestos containing Air Cell TSI located within the basement of Section 3 (Room 37). |

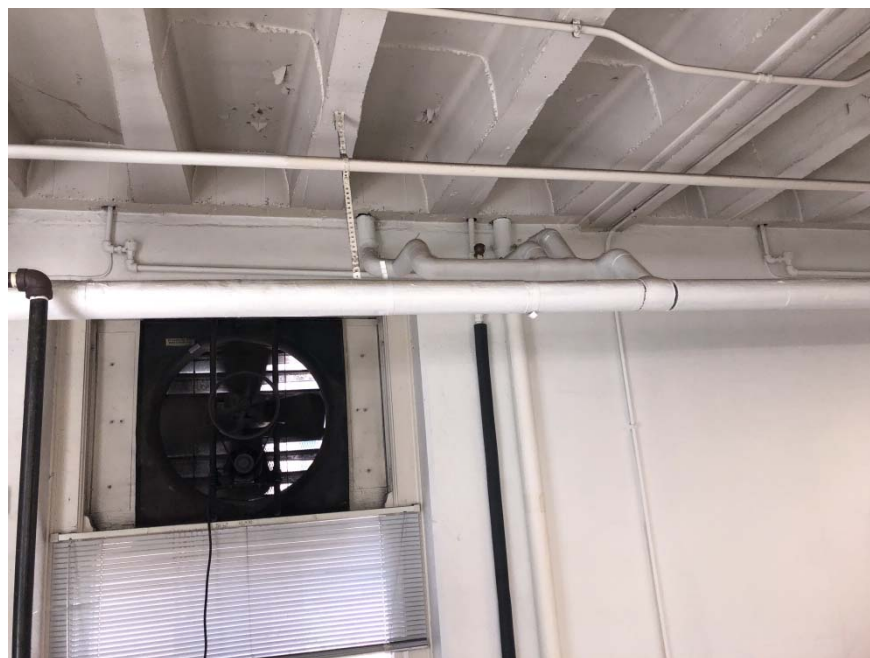
| 38 | DESCRIPTION | View of the asbestos containing TSI and fittings located within the basement of Section 3 (Room 37). |

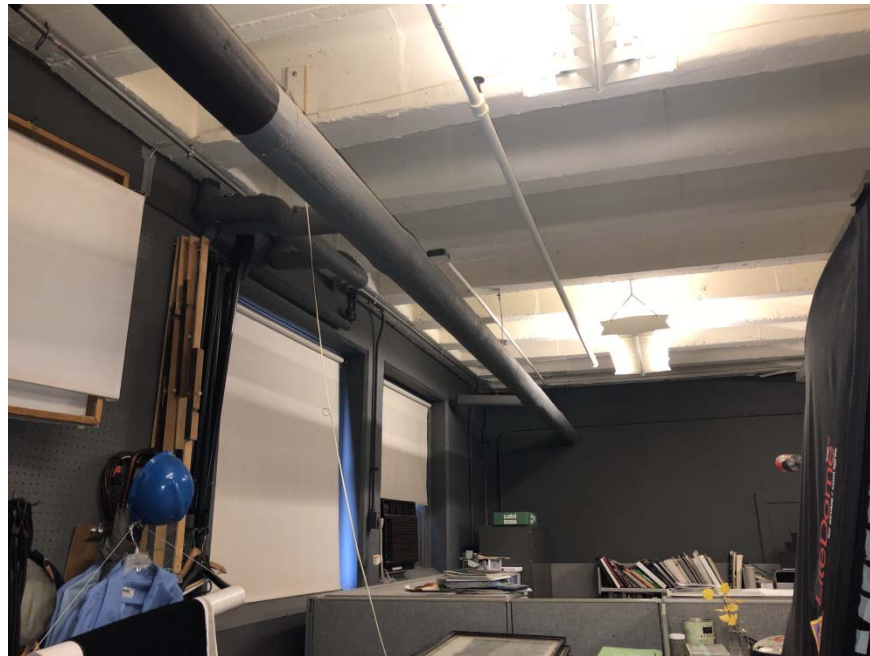
| 39 | DESCRIPTION | View of the asbestos containing TSI and fittings located within the basement of Section 3 (Room 33). |

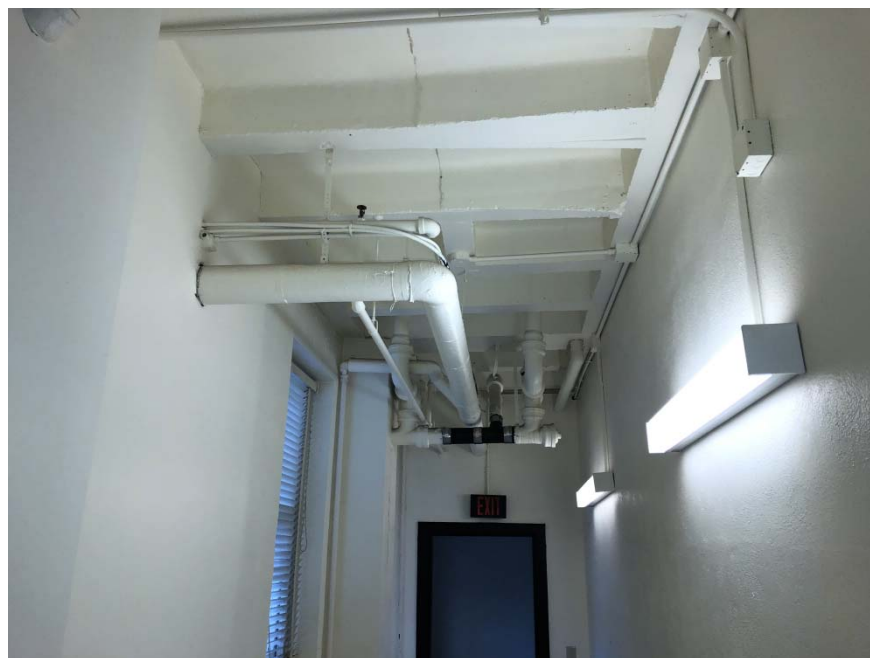
| 40 | DESCRIPTION | View of the asbestos containing TSI and fittings located within the basement of Section 3 (Room 40). |

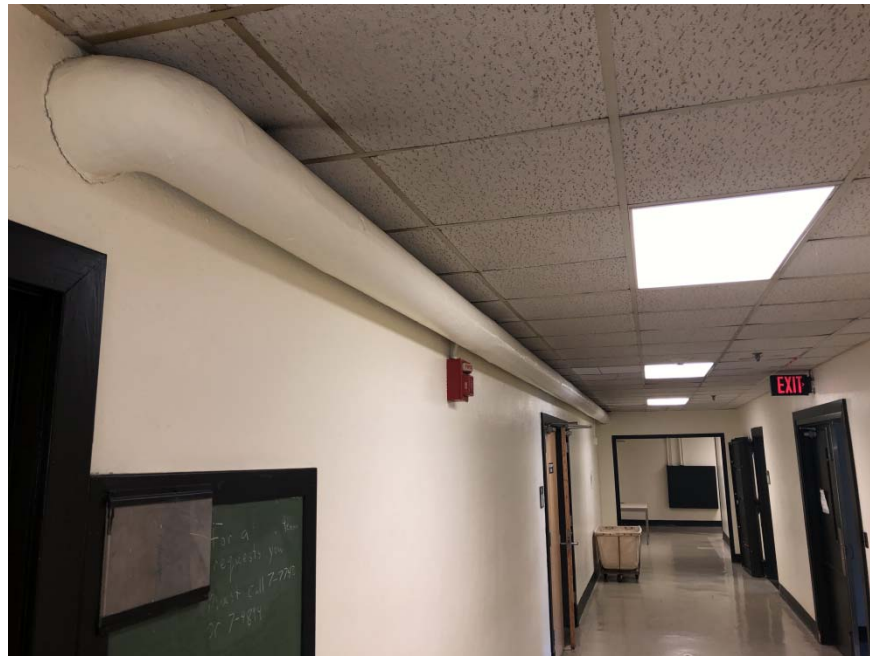
| 41 | DESCRIPTION | View of the asbestos containing TSI and elbow located within the basement of Section 3 (Hallway – 50C). |

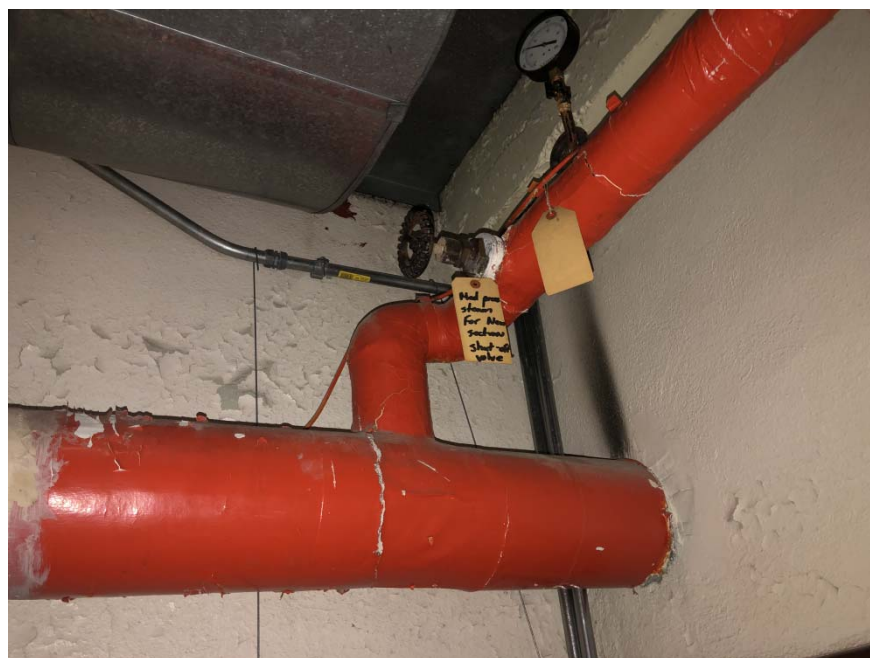
- Asbestos was historically found within the Thermal System Insulation (TSI) associated with various pipe elbows, tees, hangers, valves, and/or straight runs within Room 32 (Building Operator) located within the basement of Section 3. All associated TSI is in friable condition and considered RACM.

| 42 | DESCRIPTION | View of the asbestos containing TSI and fittings located within the basement of Section 3 (Room 32). |

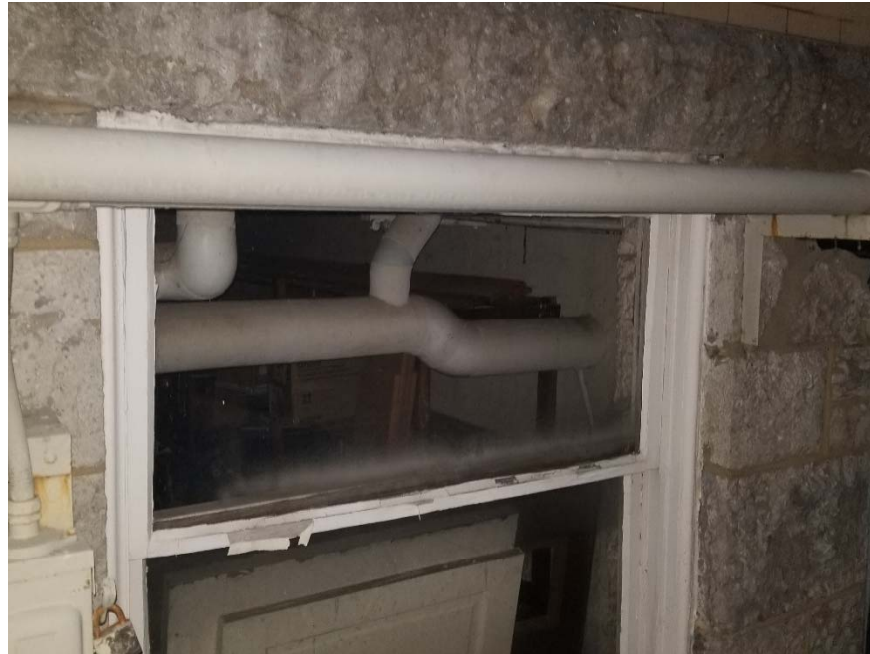
| 43 | DESCRIPTION | View of a wooden exterior basement window on Side C of Section 1. All window components are positive for LBP. |

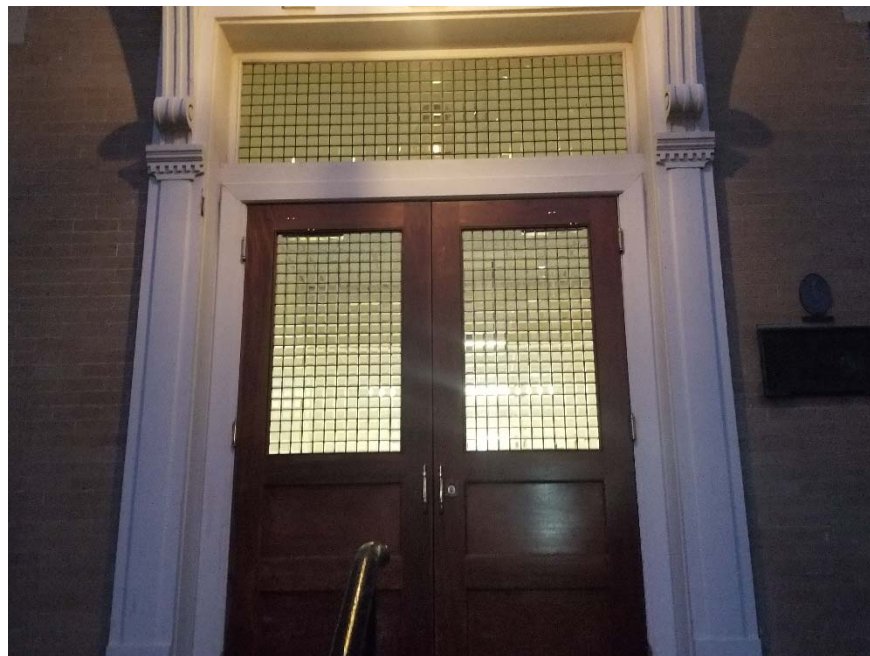
| 44 | DESCRIPTION | View of entry door on Side A of Section 1. All painted door framing and trim components are positive for LBP |

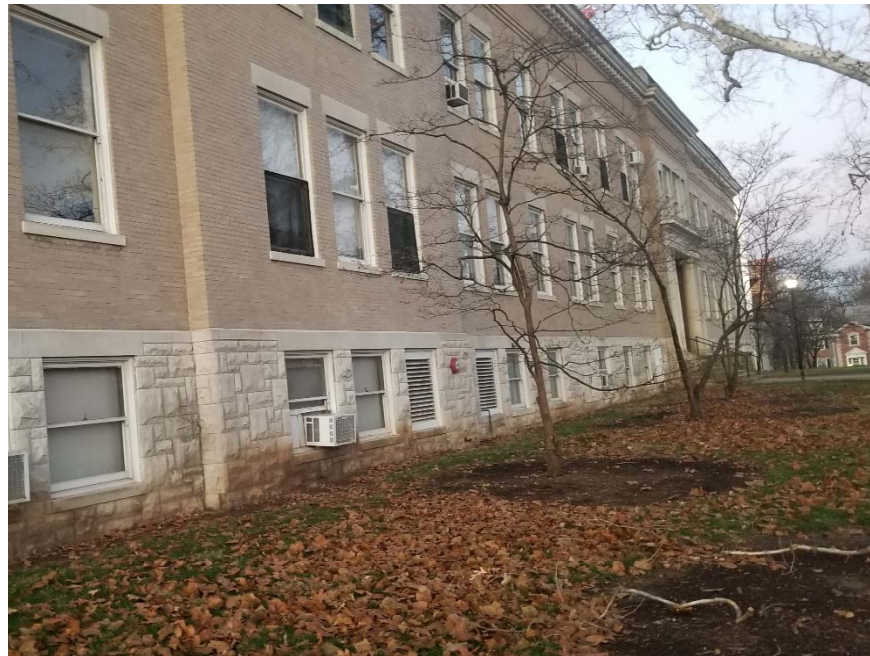
| 45 | DESCRIPTION | View of Side B of Section 1, 2 and 3. All wooden window components are positive for LBP. All roof line trim components are positive for LBP. |

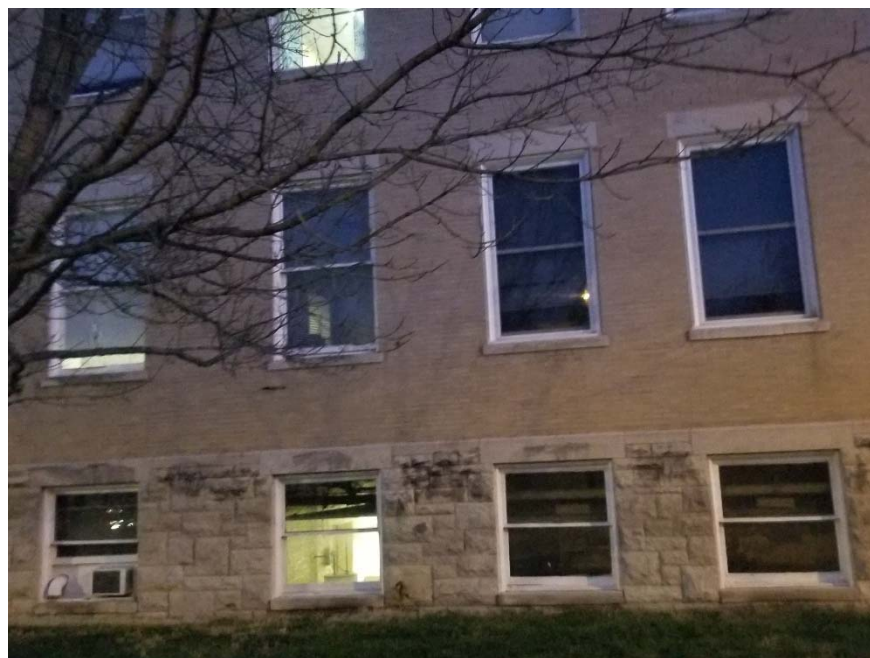
| 46 | DESCRIPTION | View of Side D of Section 1. All wooden window components are positive for LBP. |

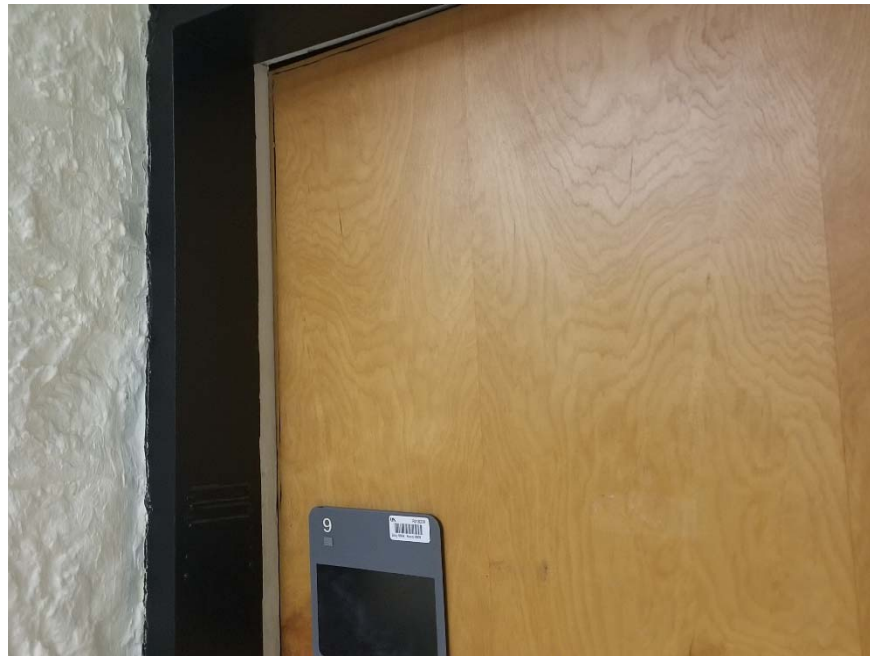
| 47 | DESCRIPTION | View of a door system in the basement hall of Section 1. The black wooden door frame is positive for LBP. |

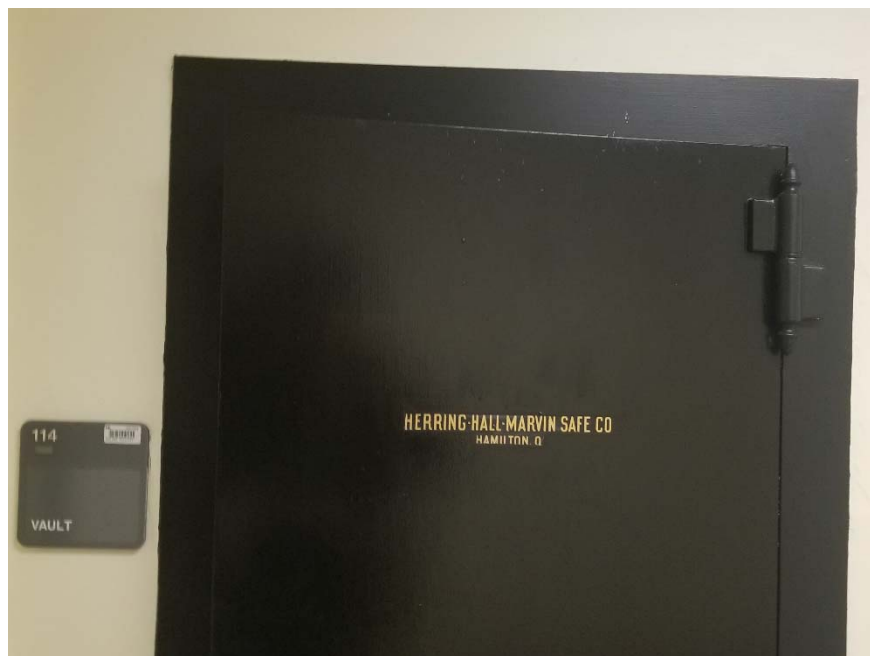
| 48 | DESCRIPTION | View a vault door system located on the 1 <sup>st</sup> floor of Section 2. All door components are positive for LBP. |

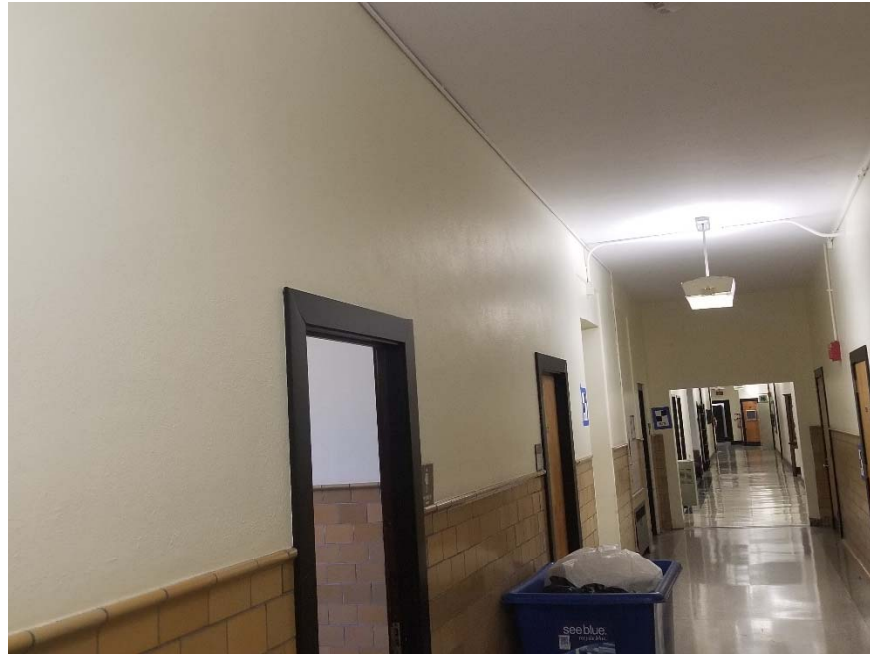
| 49 | DESCRIPTION | View of the 1 <sup>st</sup> floor hall of Section 3. The concrete walls are positive for LBP. |

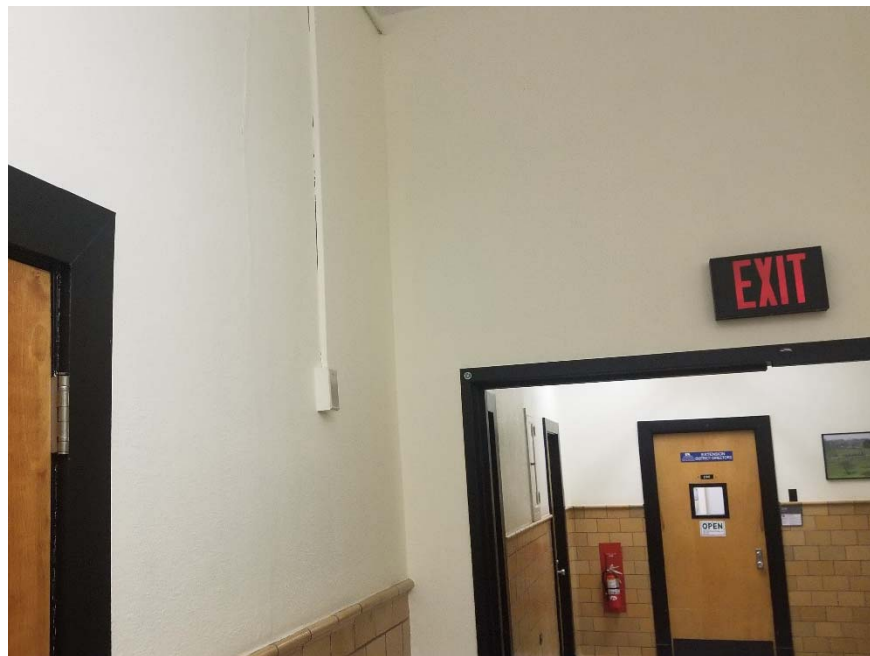
| 50 | DESCRIPTION | View of the 2 <sup>nd</sup> floor hall of Section 3. The concrete walls are positive for LBP. |

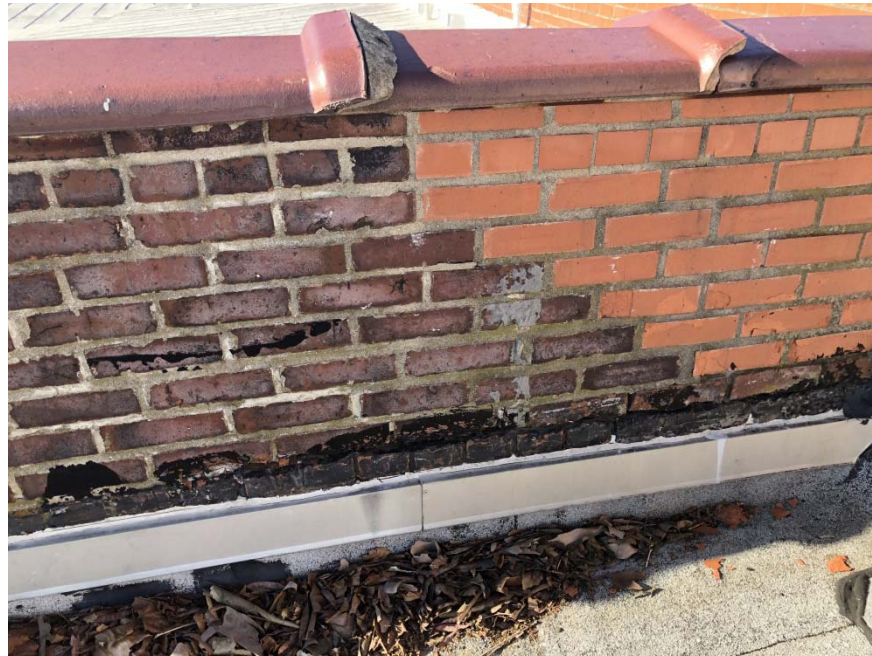
| 53 | DESCRIPTION | View of the asbestos containing tar flashing located on the brick parapet between Sections 1 & 2 of the subject building's roof. |

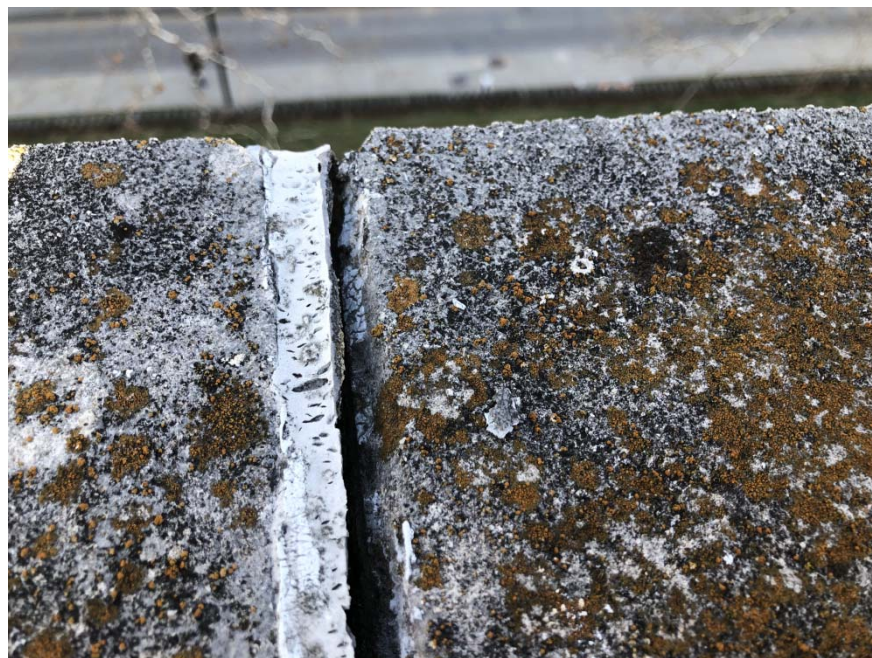
| 54 | DESCRIPTION | View of the gray asbestos containing coping seam caulk located on the parapet of Section 2's roof. |
