CCK-2590.3-1-24

Asset Preservation - Pence Hall - BP#01

PRE-DEMOLITION ASBESTOS, LEAD PAINT, AND HAZARDOUS MATERIALS INSPECTION

University of Kentucky – Pence Hall
175 Funkhouser Drive
Lexington, Kentucky 40506

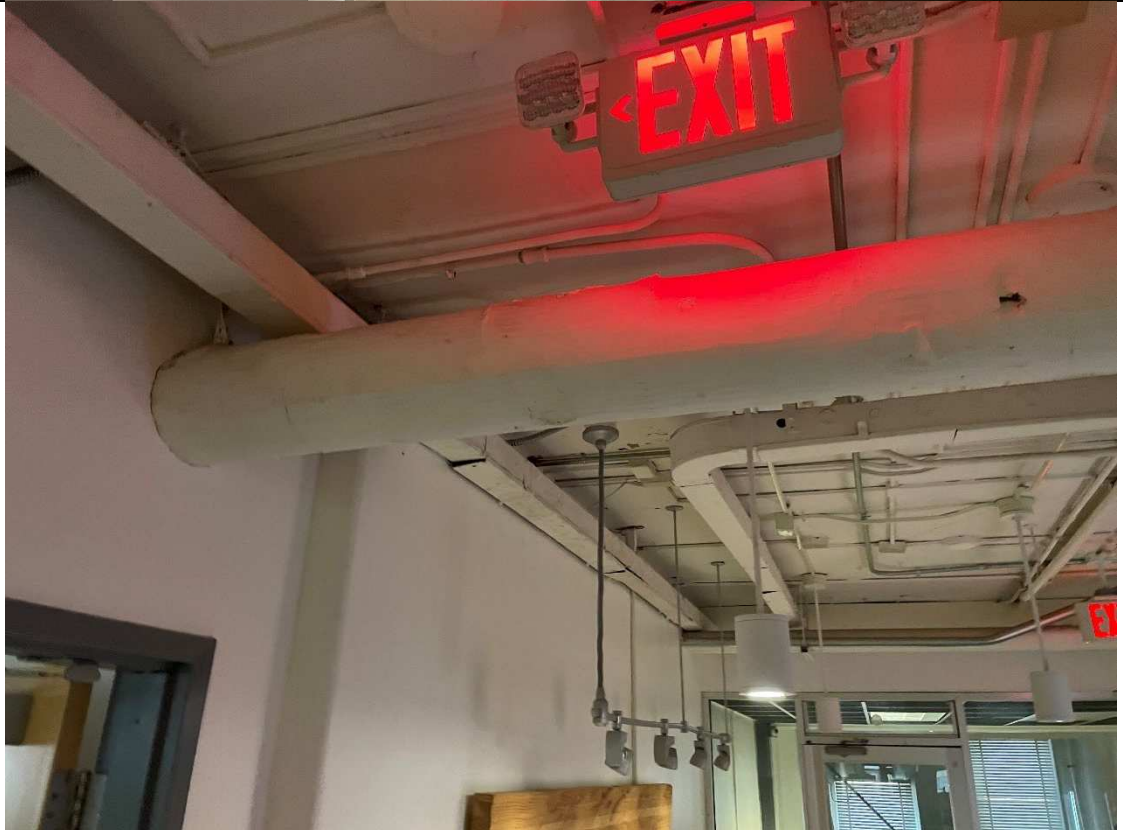
Photo No:
010

Description:
View of the
basement lobby
area (Room 001).
This large pipe
wrap/canvas cover
(ref. sample B-
01A/B) is positive
for asbestos.

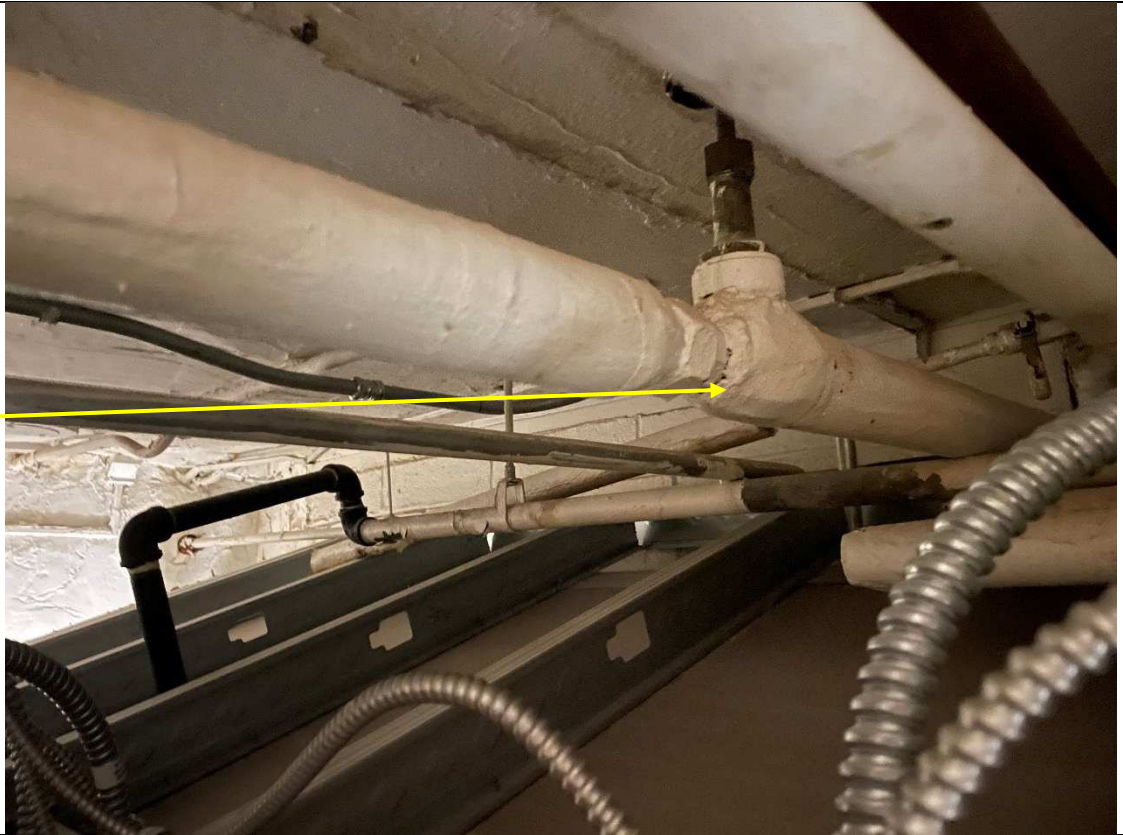
Description:
View of piping
above suspended
ceiling in room
009C showing
asbestos containing
piping.

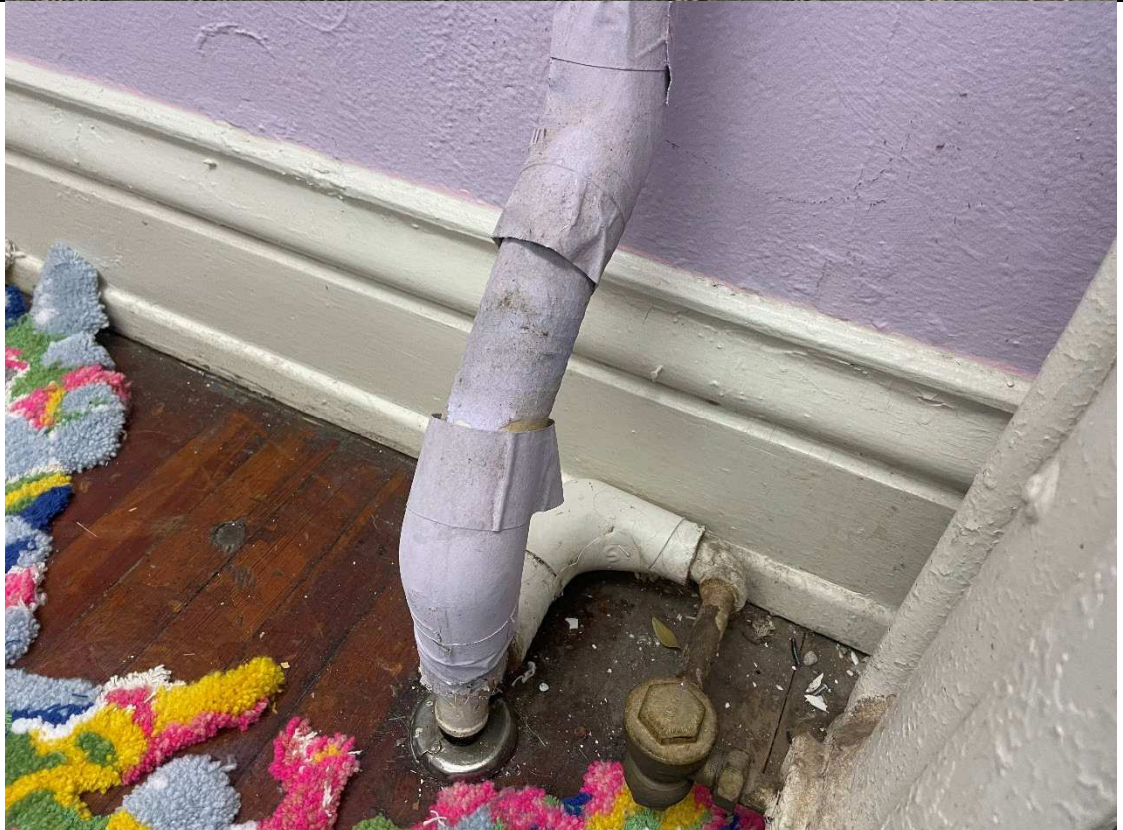
View of room 203 showing various wrapped mechanical components containing asbestos.

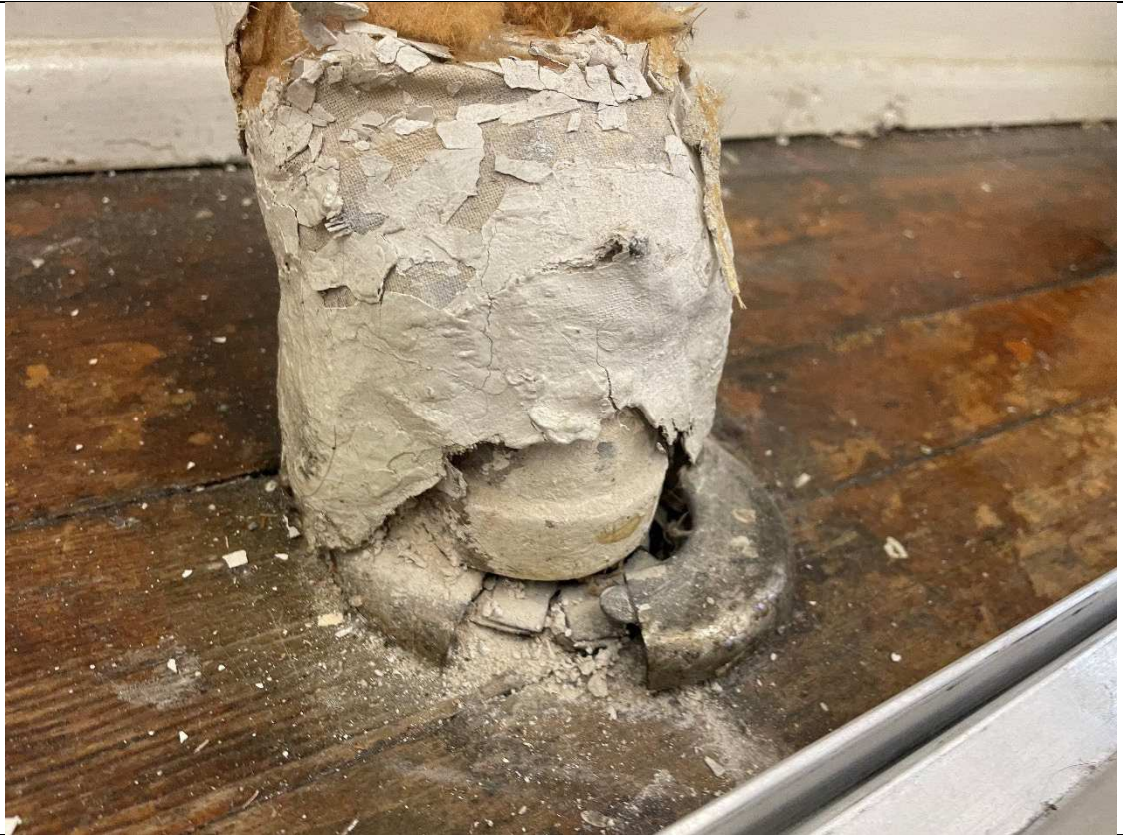
Description:
View of classroom
202 showing
damaged asbestos.
Other pipes within
this room have
similar issues.

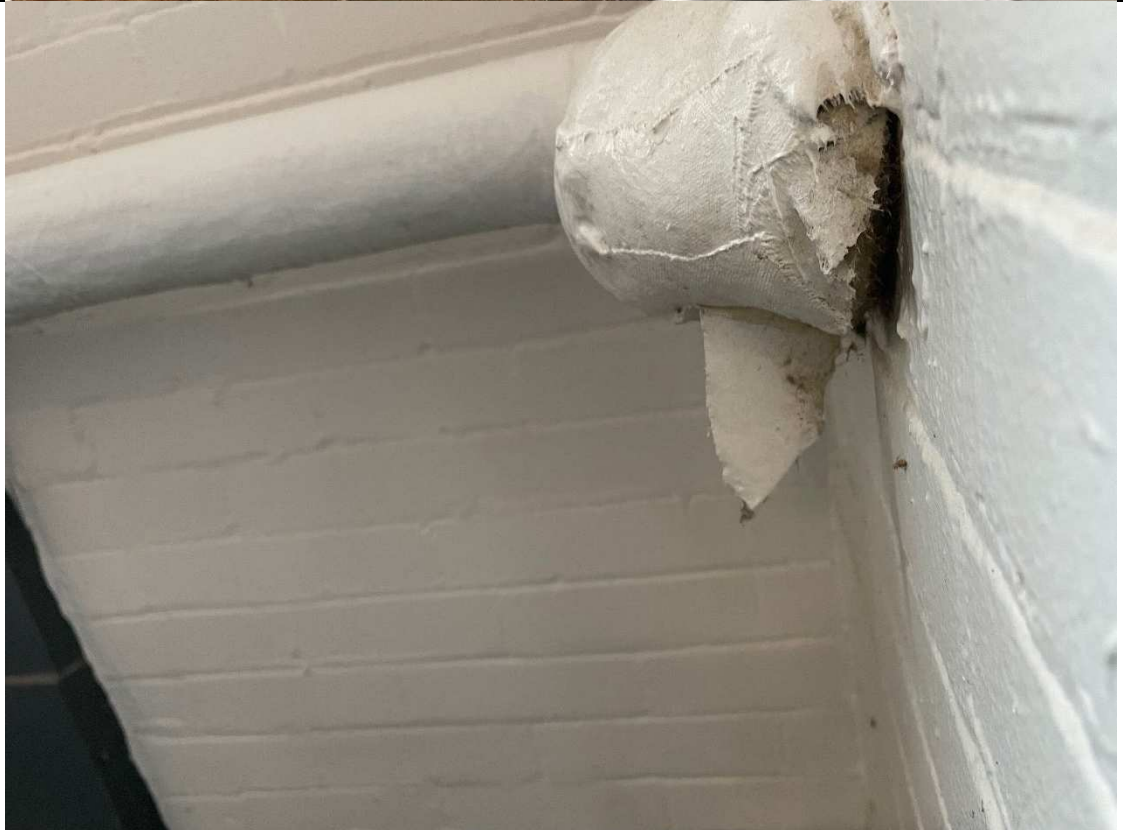
Photo No:
024

Description:
View of classroom
202 showing
damaged asbestos.
Other pipes within
this room have
similar issues.

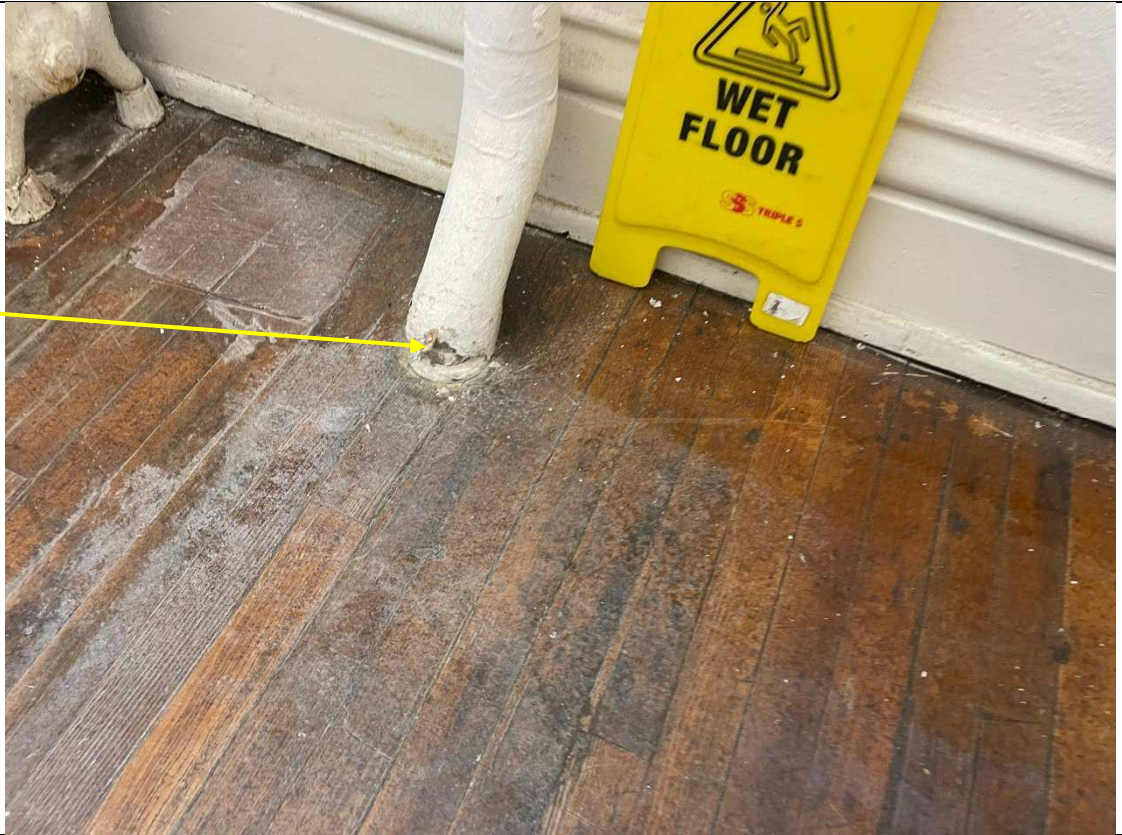
View of classroom 202 showing damaged asbestos. Other pipes within this room have similar issues.

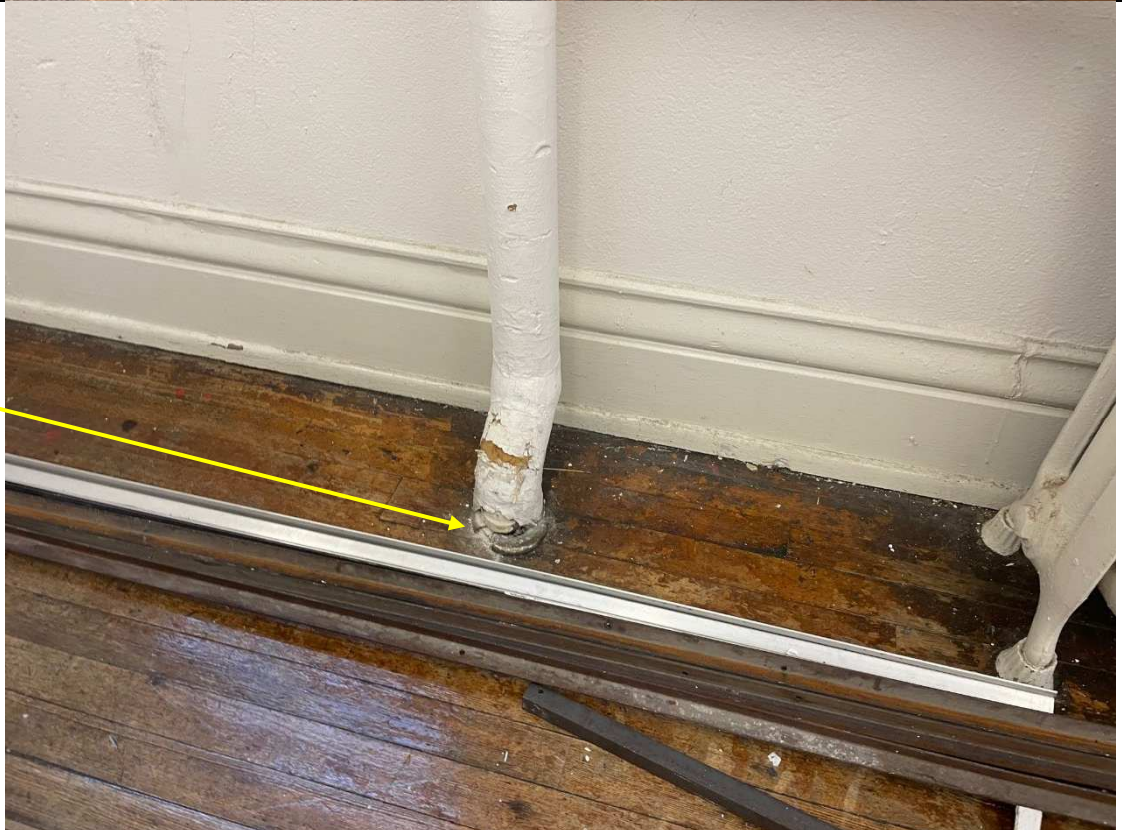
Photo No:

View of classroom 202 showing damaged asbestos. Other pipes within this room have similar issues.

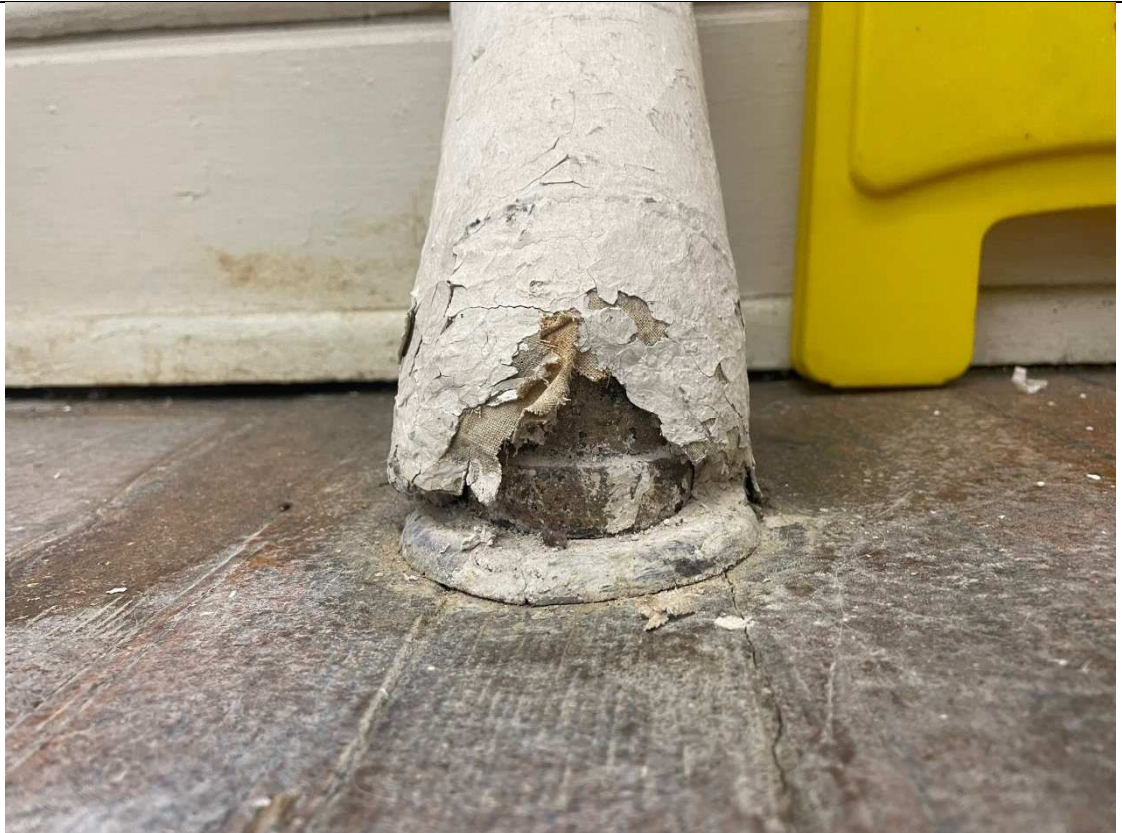
View of classroom 202 showing damaged asbestos. Other pipes within this room have similar issues.

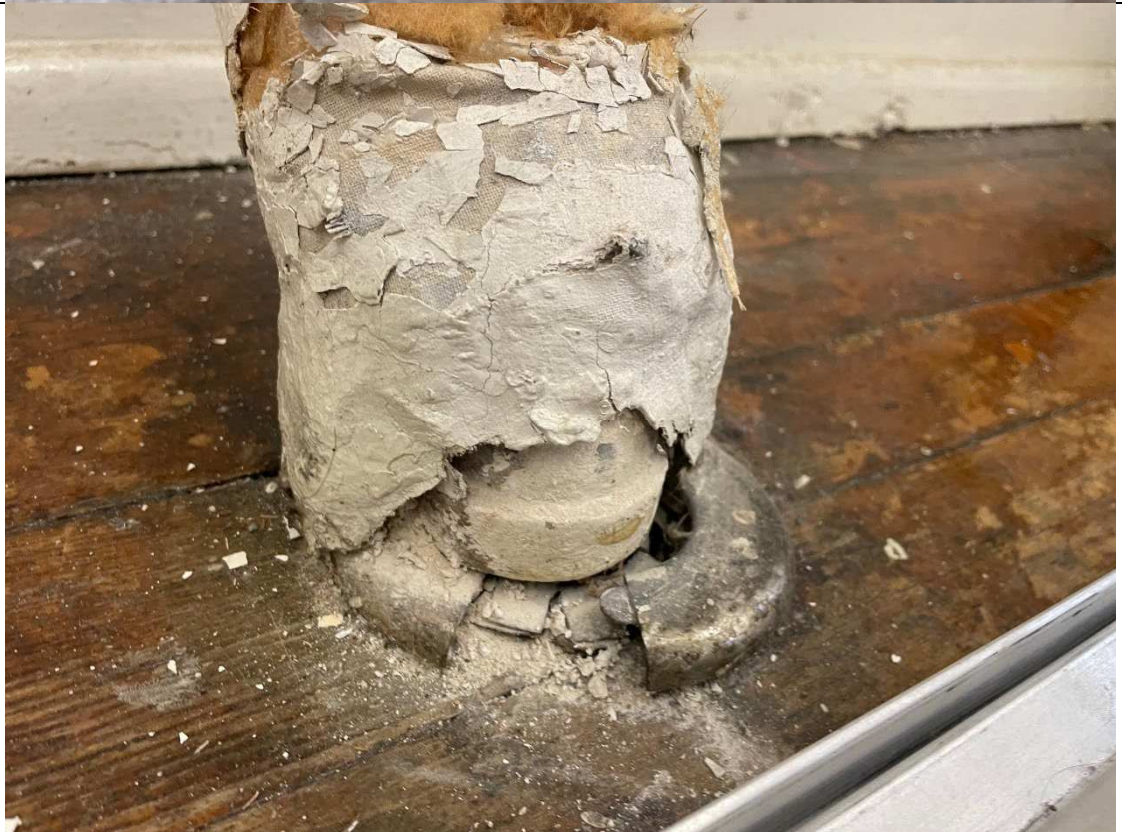
Photo No:

View of classroom 202 showing damaged asbestos. Other pipes within this room have similar issues.

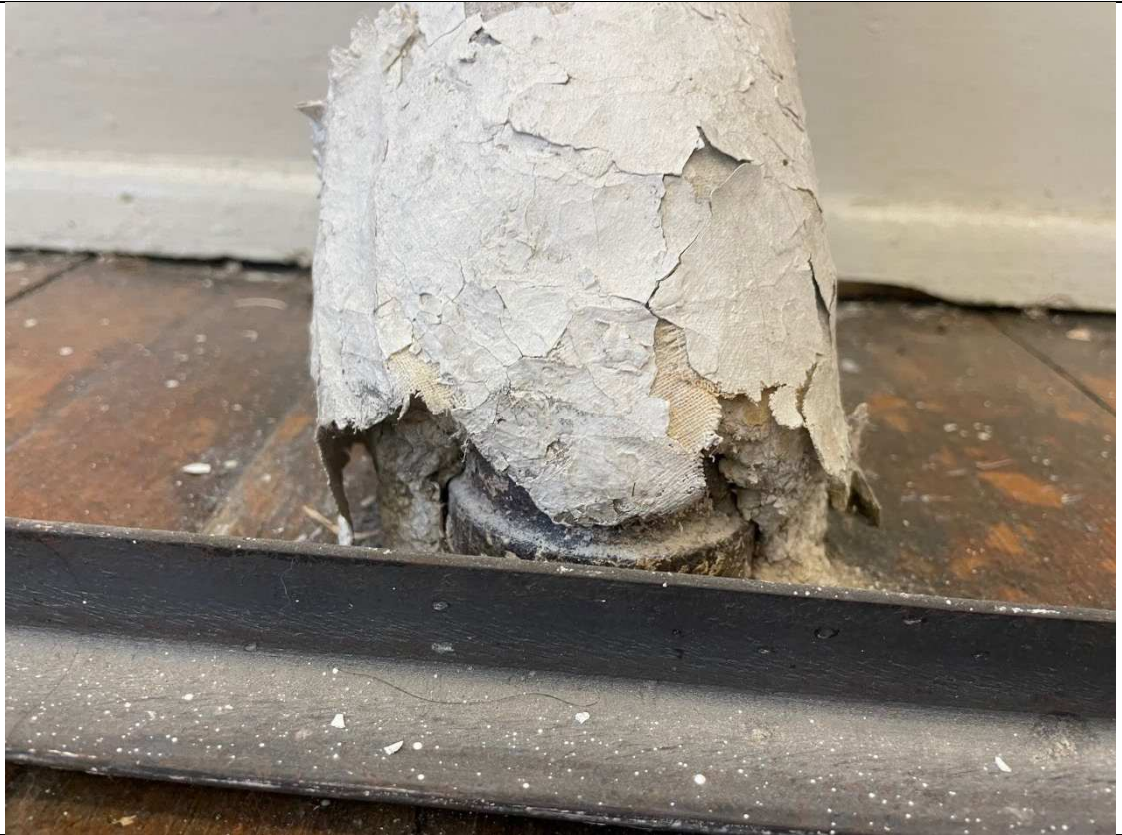
View of classroom 202 showing damaged asbestos. Other pipes within this room have similar issues.

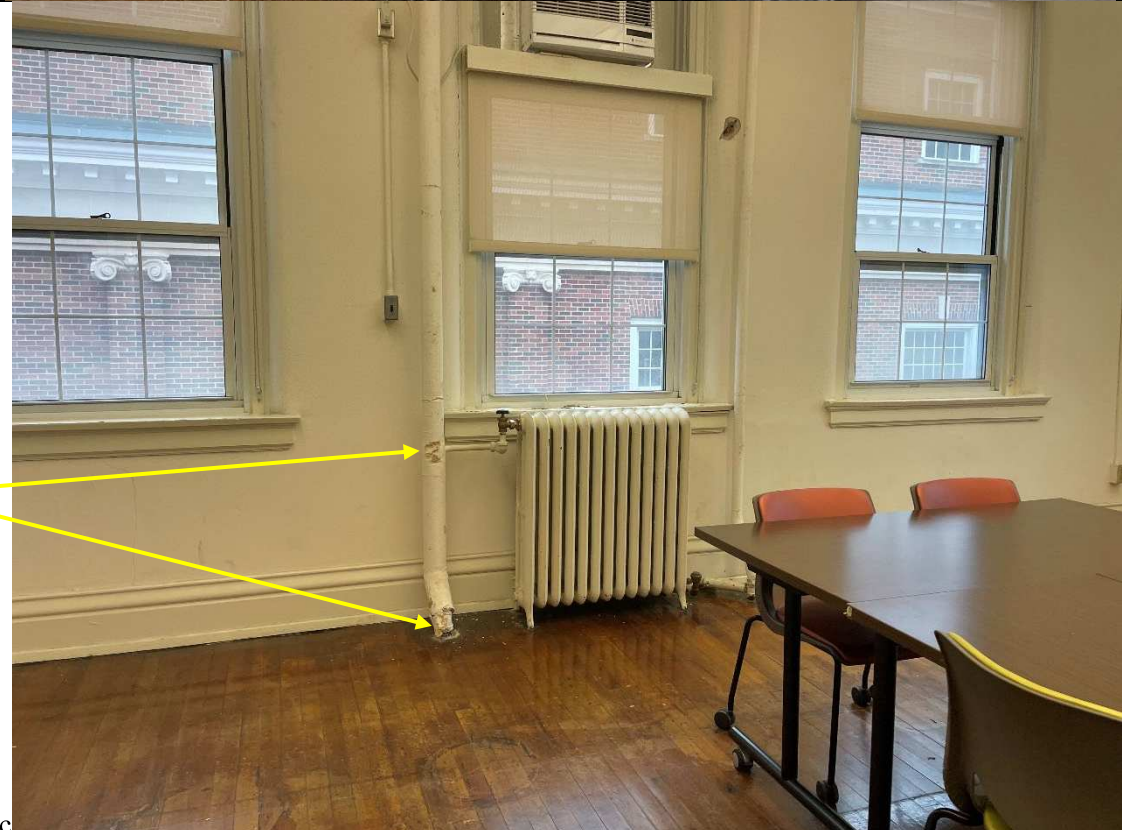
Photo No:

View of classroom 204 (Reference Room) showing damaged asbestos near radiator. Other pipes within this room have similar issues.

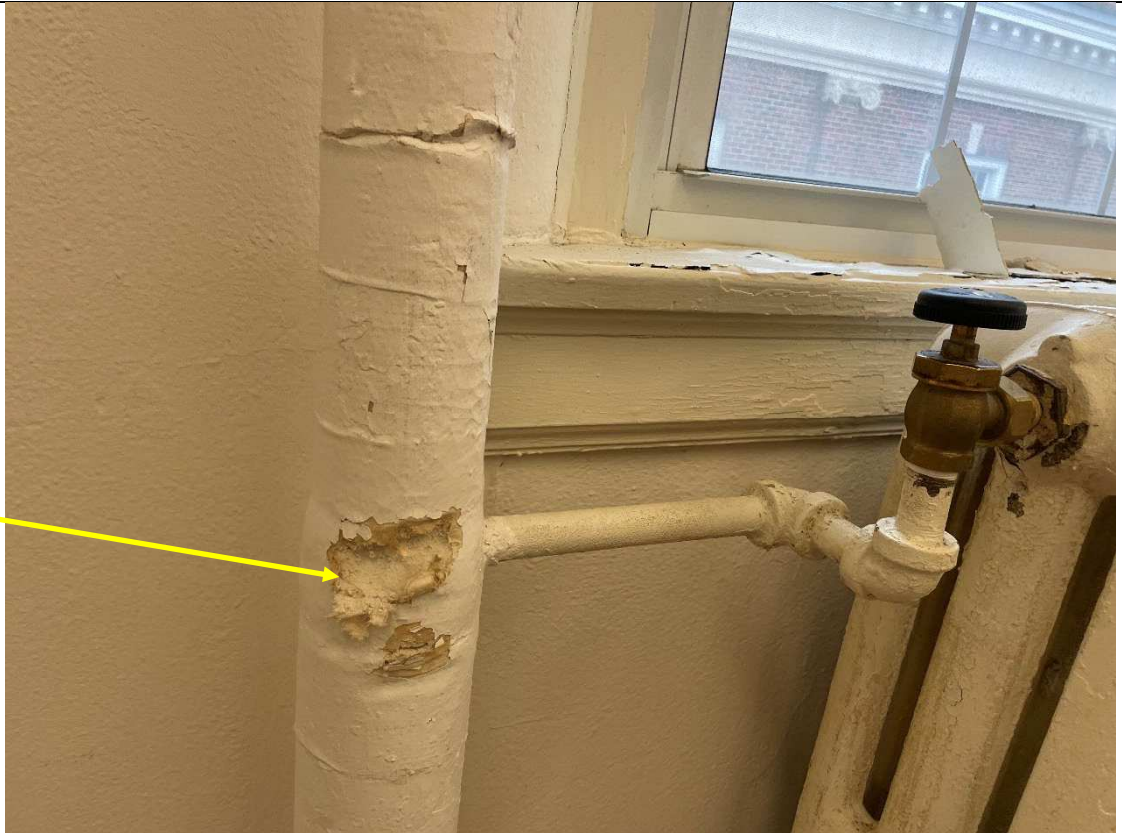
View of classroom 204 (Reference Room) showing damaged asbestos near radiator. Other pipes within this room have similar issues.

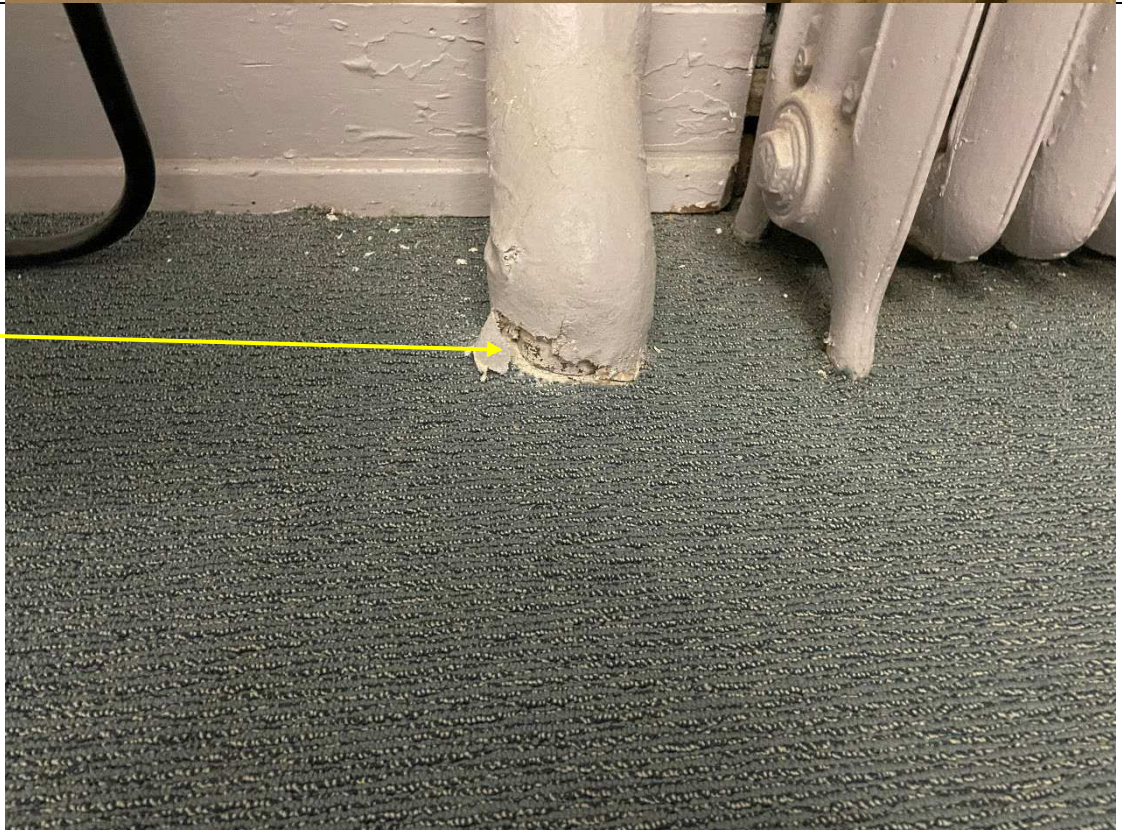
View of room 205 showing damaged asbestos near radiator.

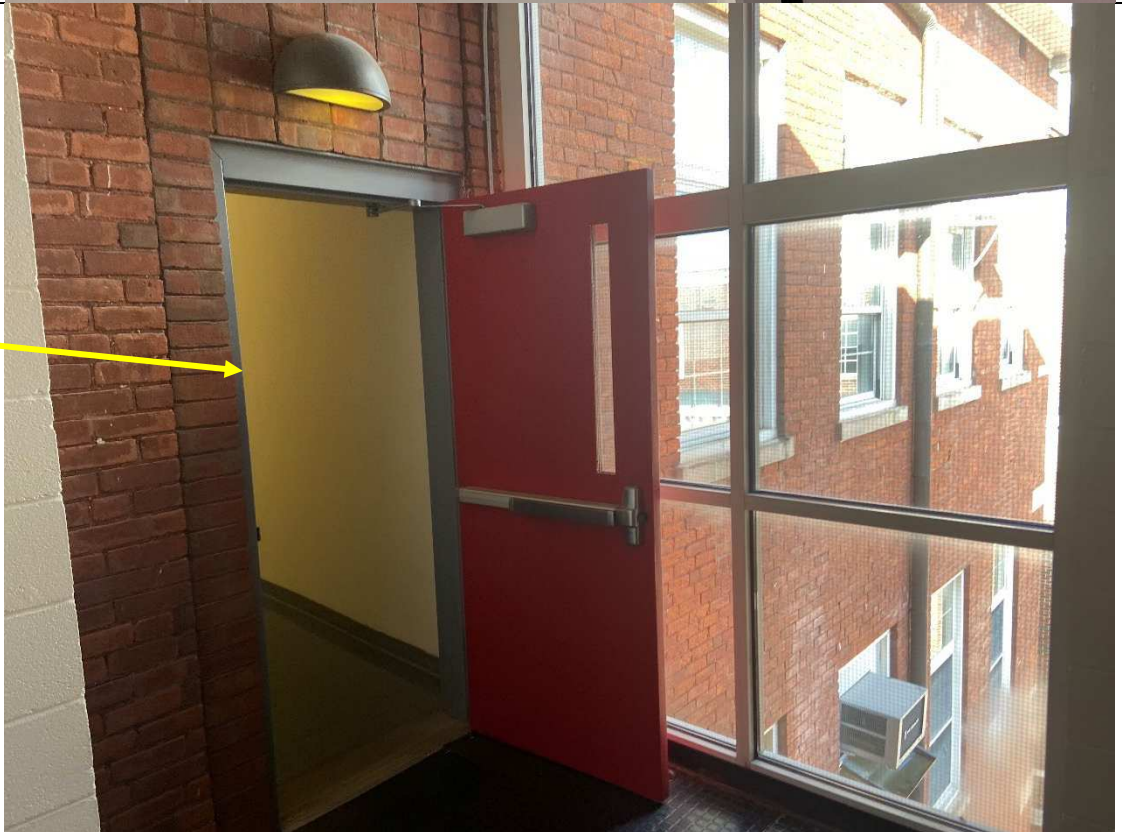
Photo No:
050

Description:
Location of
Residual Door
Caulk.

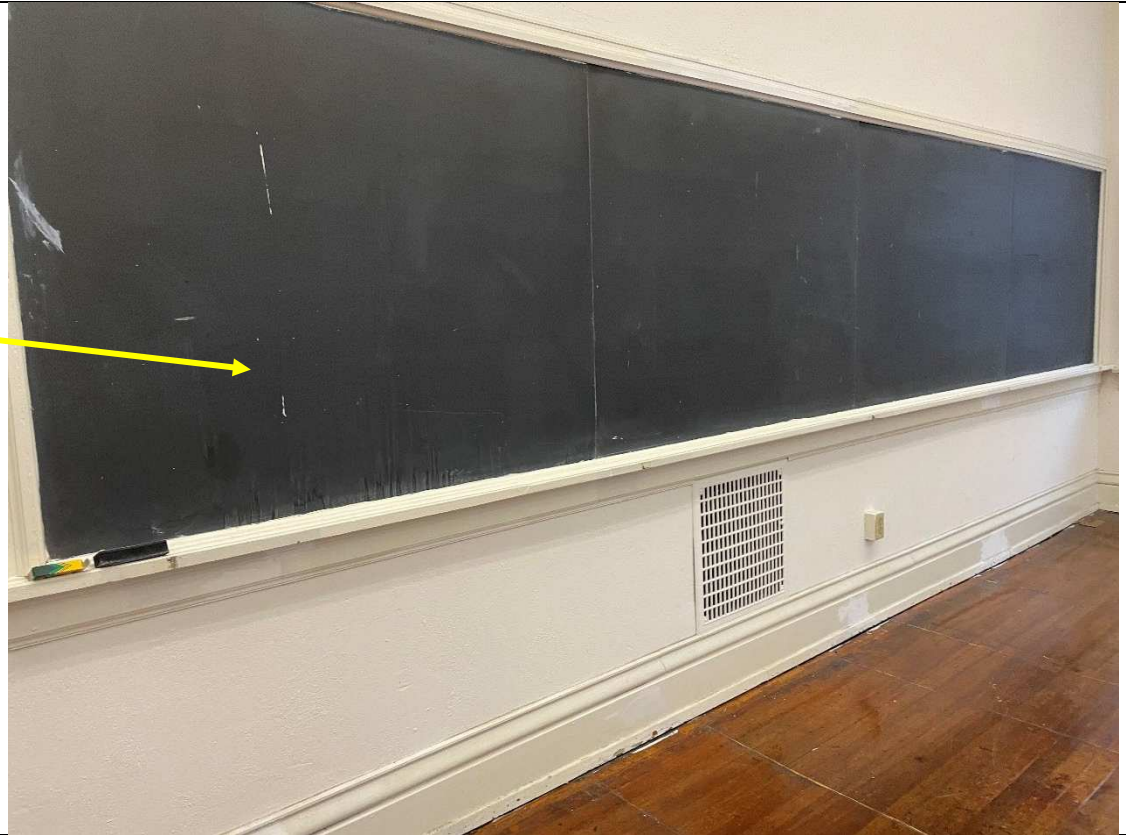
Chalk boards were not disturbed as part of the inspection; however, it is assumed adhesive behind is asbestos containing.

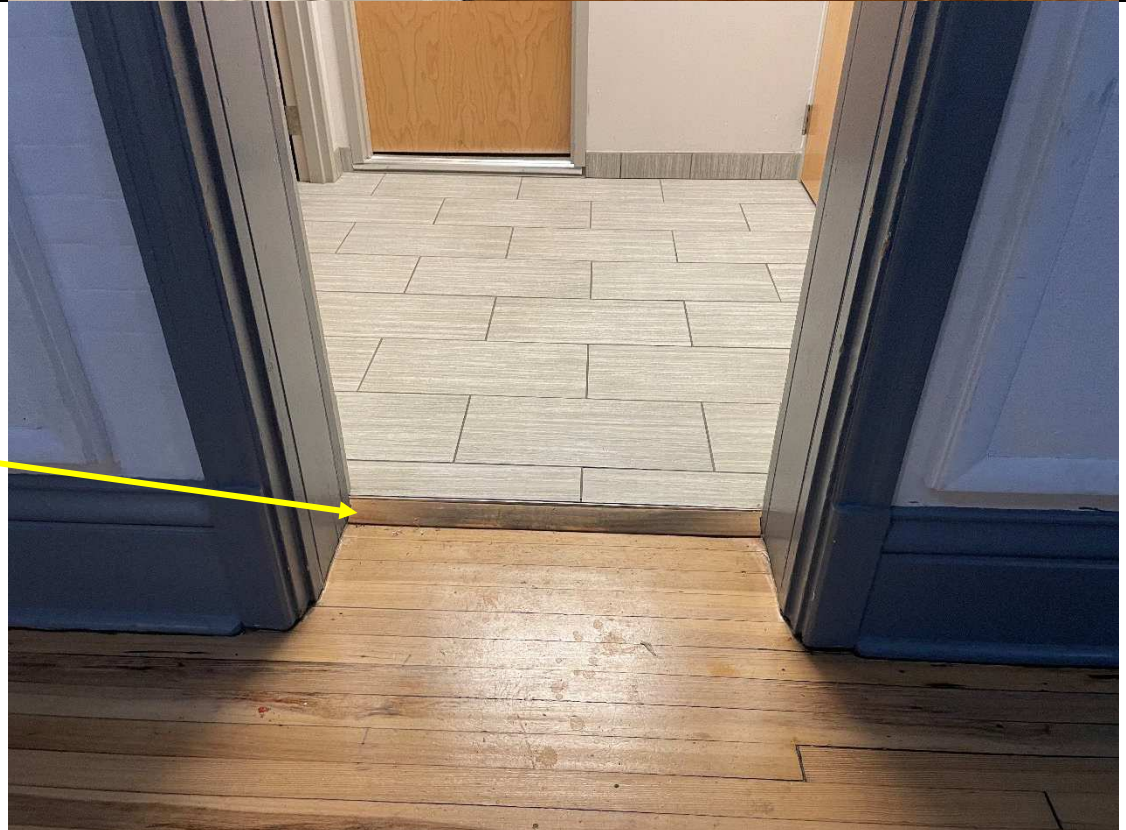
Location of new flooring that could potentially be over asbestos containing tile per information received from UK. This area appears built up approximately 1". This area is assumed to contain 9x9" floor tile and mastic until confirmation/area disturbance can occur.

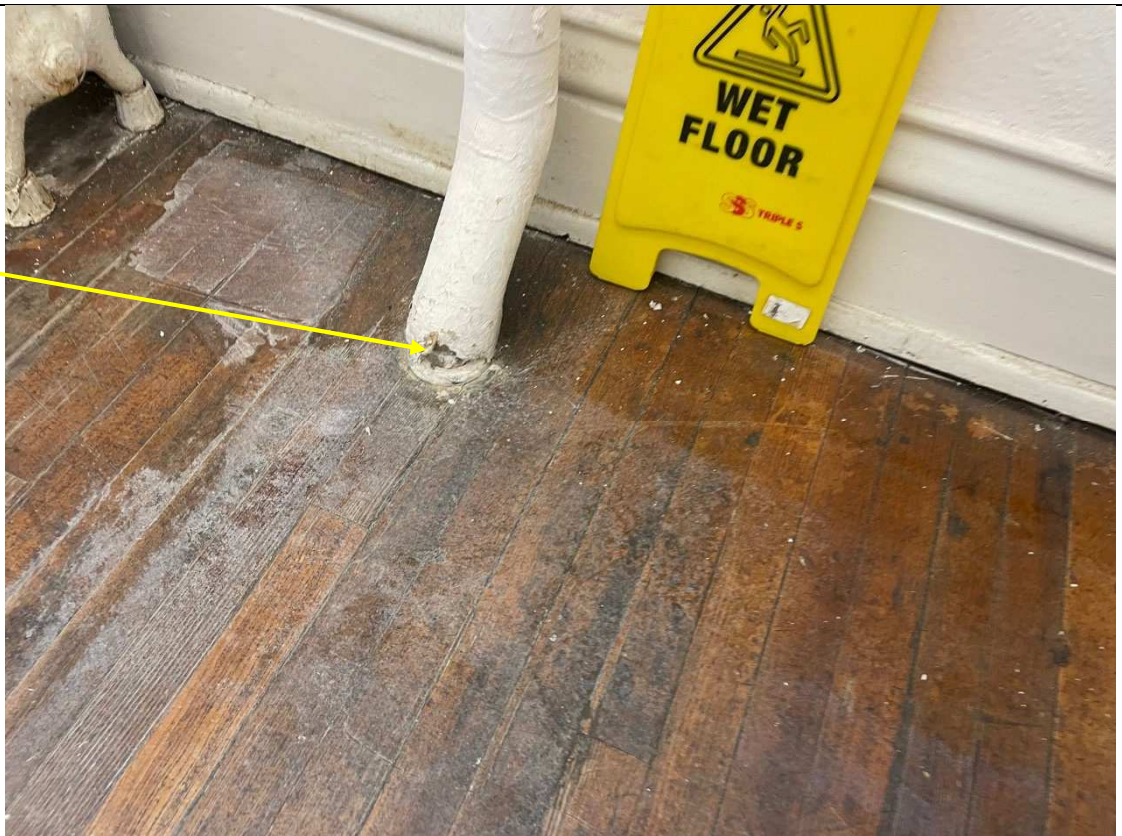
Classroom 202 showing damaged asbestos. Other pipes within this room have similar issues. These issues need to be repaired prior to occupancy of this room by a Kentucky Certified Asbestos Abatement Company including air clearance sampling.

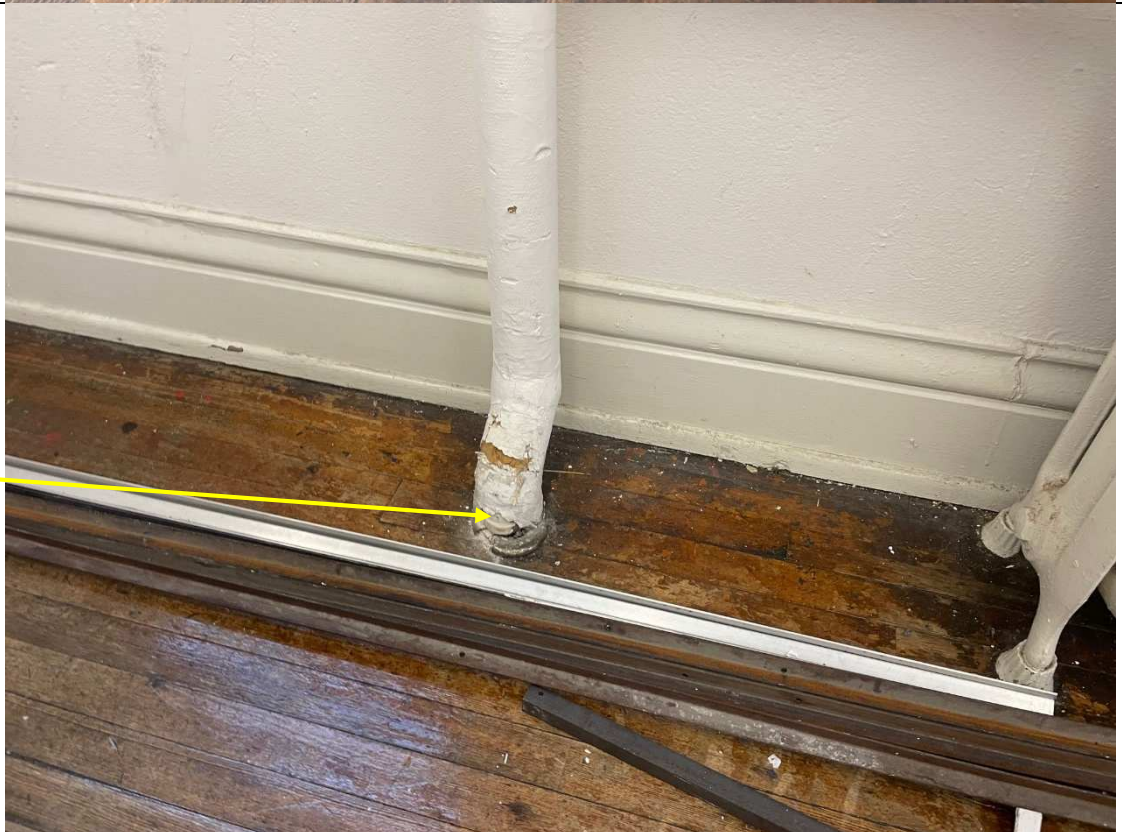
Photo No:

Classroom 202 showing damaged asbestos. Other pipes within this room have similar issues. These issues need to be repaired prior to occupancy of this room by a Kentucky Certified Asbestos Abatement Company including air clearance sampling.

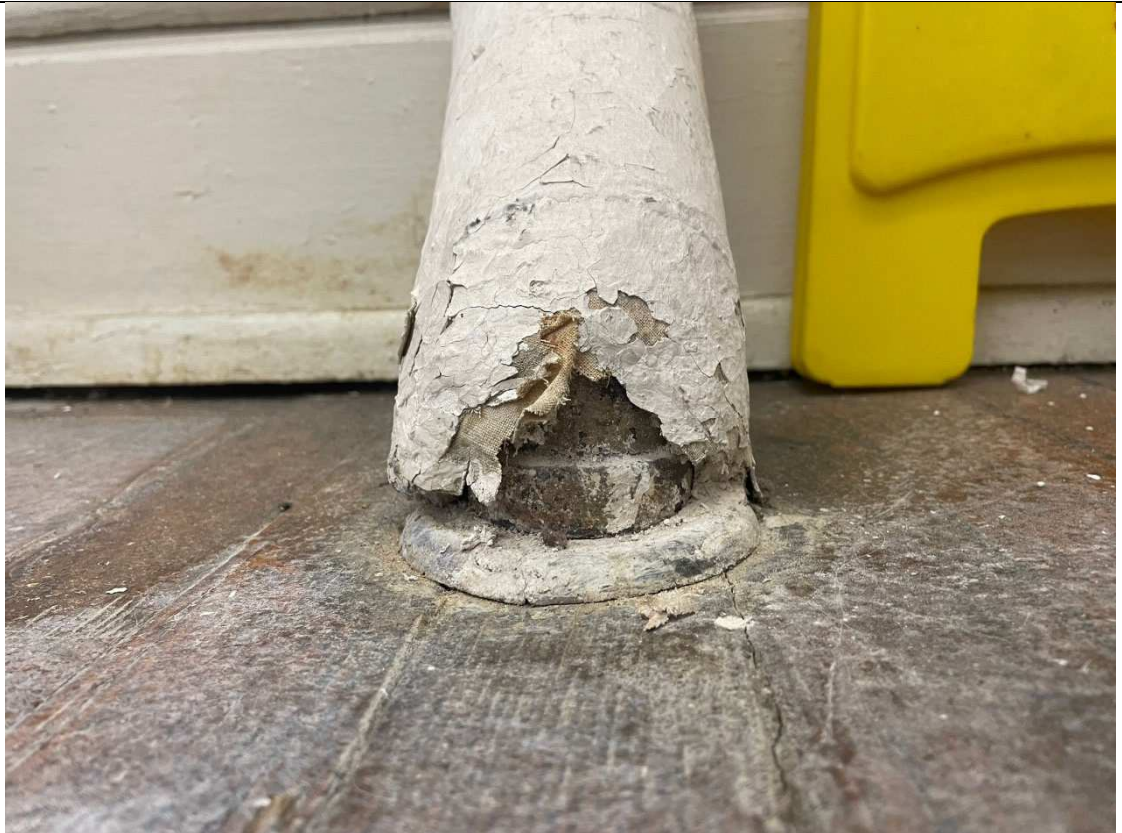
Classroom 202 showing damaged asbestos. Other pipes within this room have similar issues. These issues need to be repaired prior to occupancy of this room by a Kentucky Certified Asbestos Abatement Company including air clearance sampling.

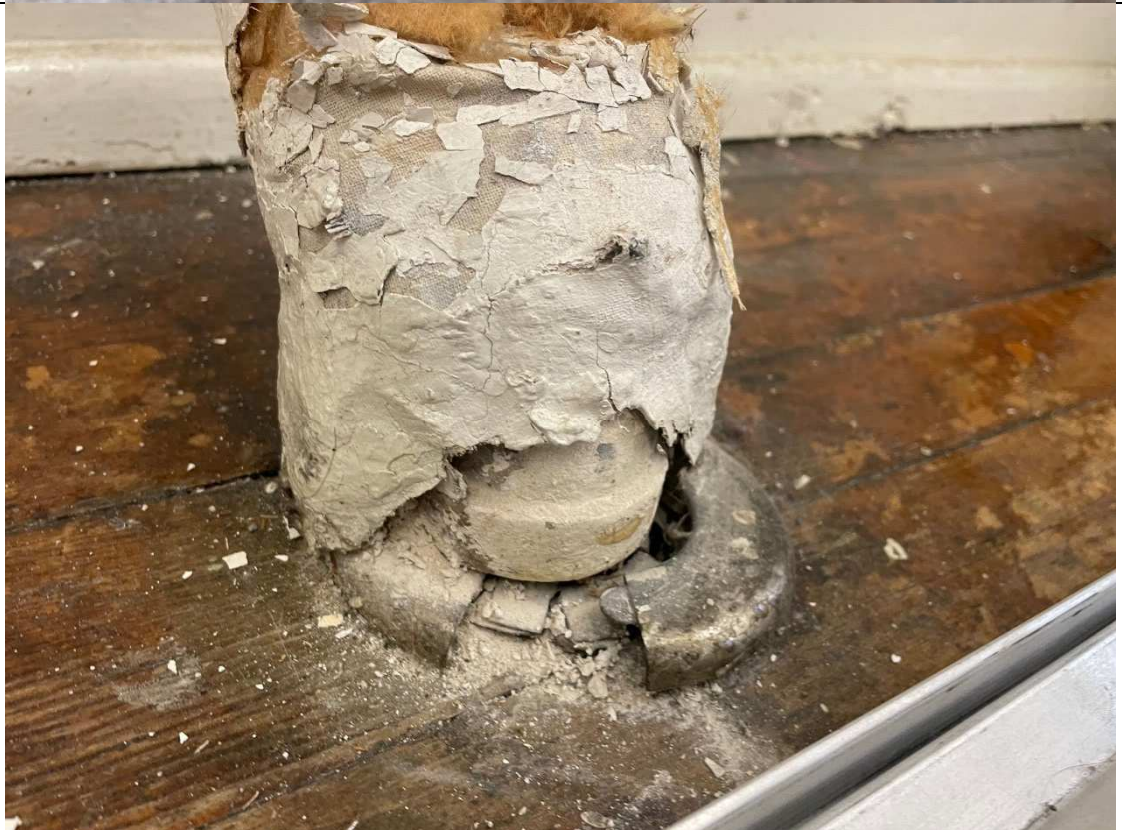
Photo No:

Classroom 202 showing damaged asbestos. Other pipes within this room have similar issues. These issues need to be repaired prior to occupancy of this room by a Kentucky Certified Asbestos Abatement Company including air clearance sampling.

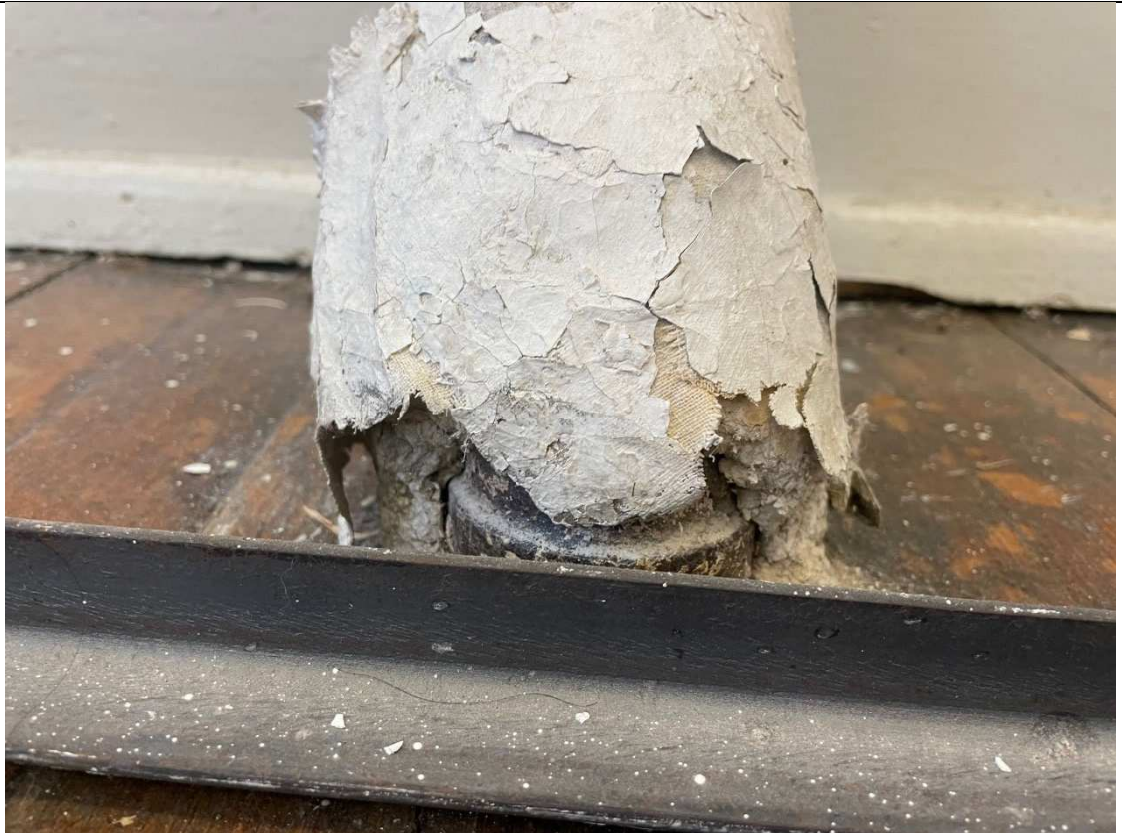
Classroom 202 showing damaged asbestos. Other pipes within this room have similar issues. These issues need to be repaired prior to occupancy of this room by a Kentucky Certified Asbestos Abatement Company including air clearance sampling.

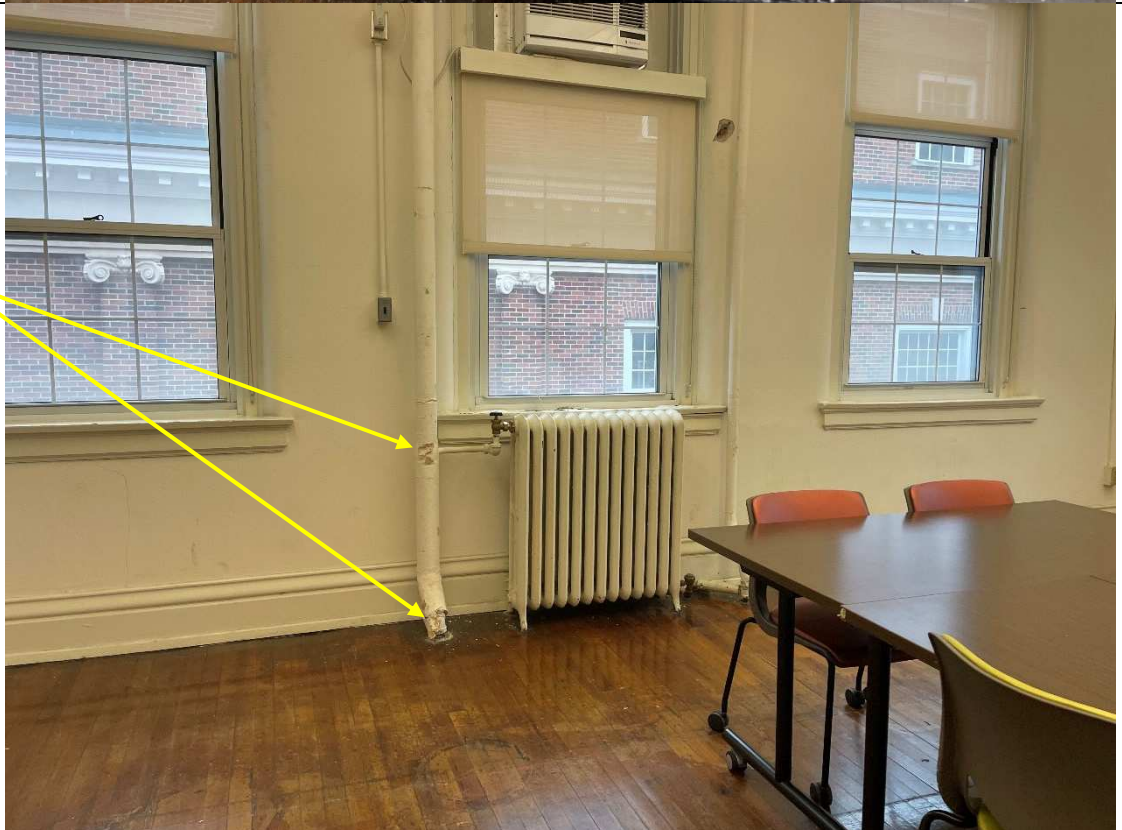
Description: Room 204 (Reference Room) showing damaged asbestos near radiator. Other pipes within this room have similar issues. These issues need to be repaired prior to occupancy of this room by a Kentucky Certified Asbestos Abatement Company including air clearance sampling.

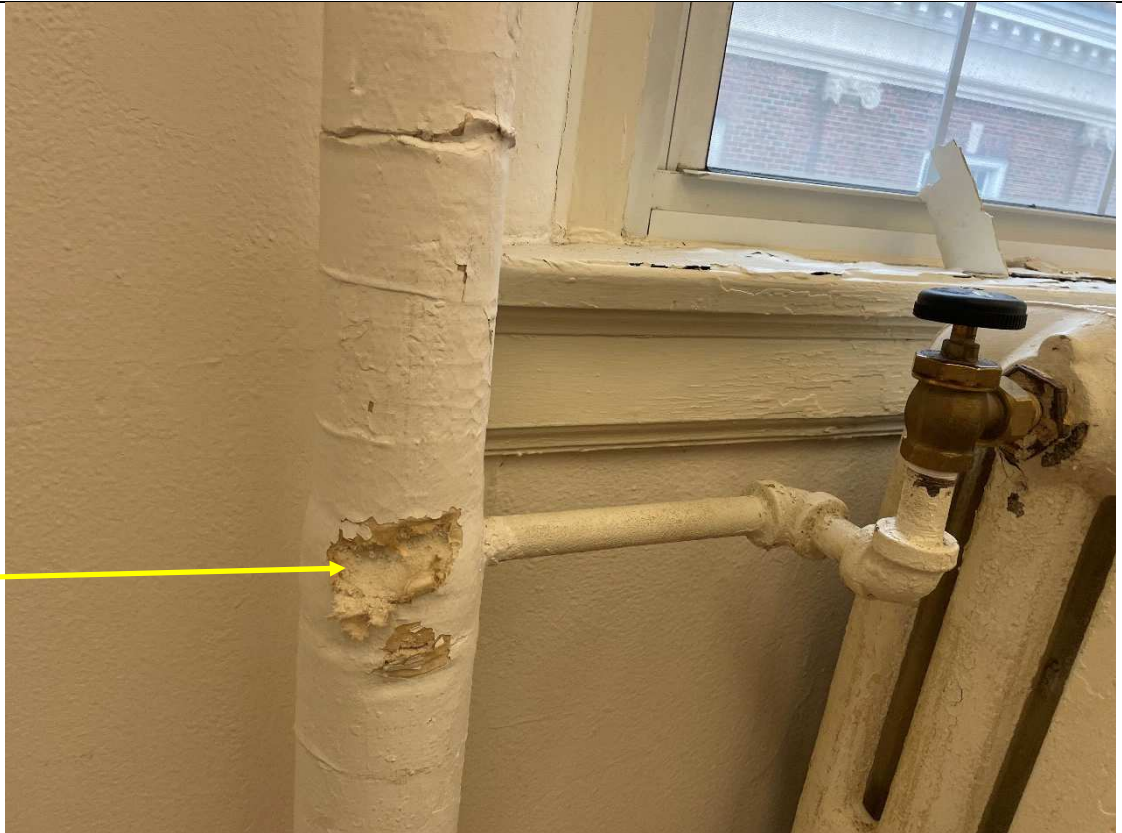
Description: Room 204 (Reference Room) showing damaged asbestos near radiator. Other pipes within this room have similar issues. These issues need to be repaired prior to occupancy of this room by a Kentucky Certified Asbestos Abatement Company including air clearance sampling.
