CCK-2590.3-1-24

Asset Preservation - Pence Hall - BP#01

PRE-DEMOLITION ASBESTOS, LEAD PAINT, AND HAZARDOUS MATERIALS INSPECTION

University of Kentucky – Pence Hall
175 Funkhouser Drive
Lexington, Kentucky 40506

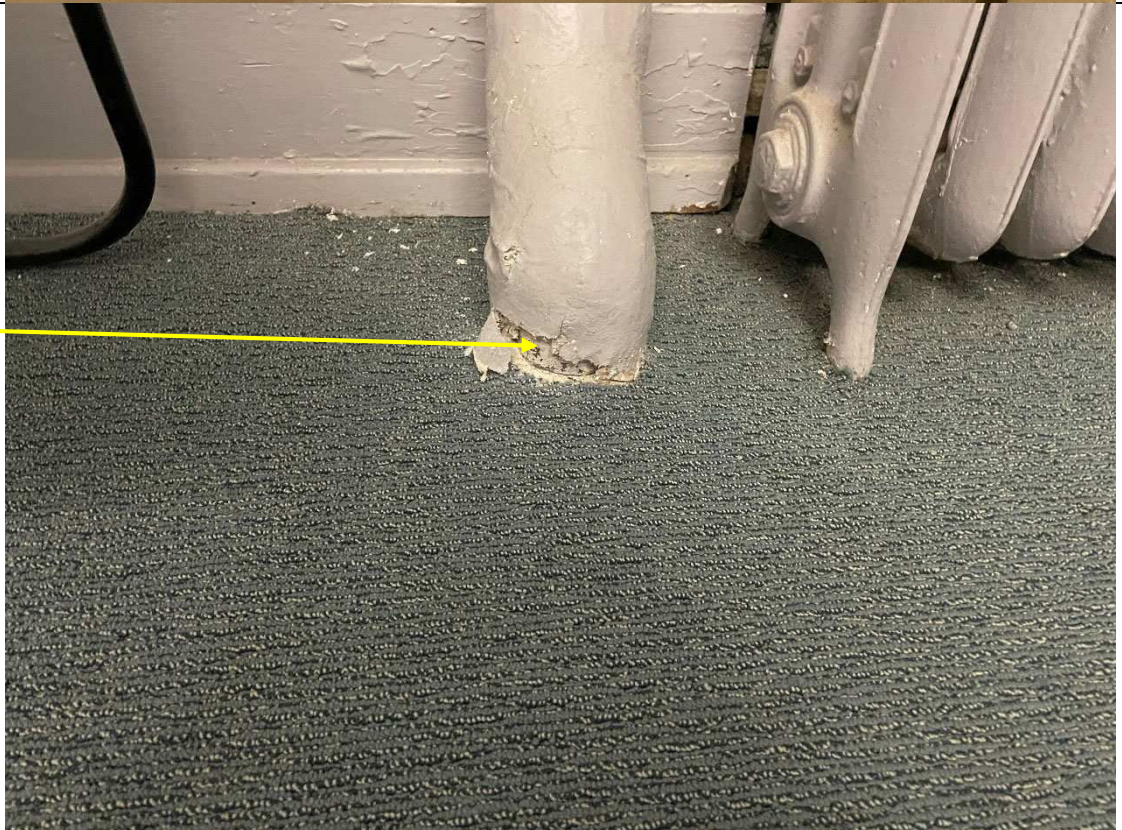
Photo No:
008

Description: Room 205 showing damaged asbestos near radiator. These issues need to be repaired prior to occupancy of this room by a Kentucky Certified Asbestos Abatement Company including air clearance sampling.
