### ADDENDUM No. 3

## Early Subcontractor Involvement (ESI) 010 - Building Demolition

### Competitive Negotiation

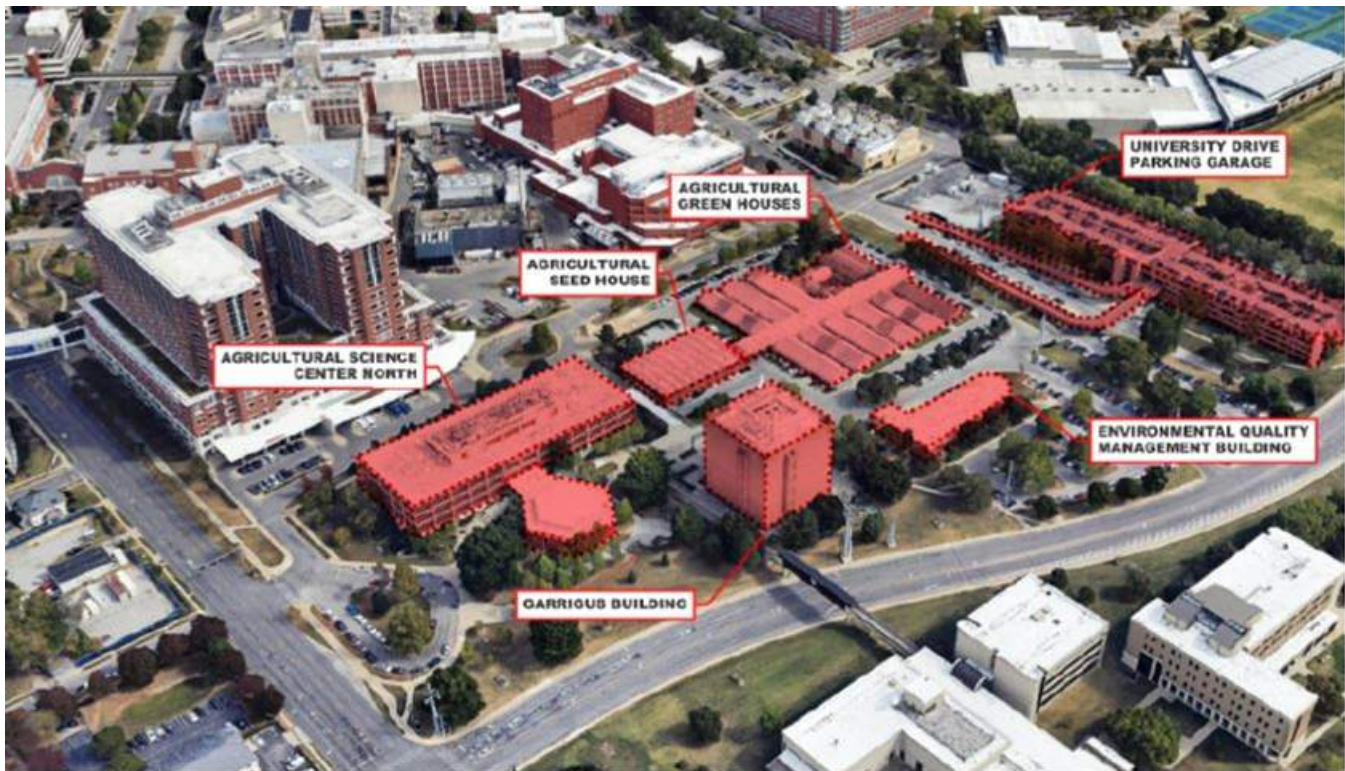
#### **Schematic of structures to be demolished from Schematic Design documents**

The project site is currently occupied by 6 existing structures that include the Agricultural Science Center North, the Agricultural Seed House, agricultural greenhouses, the Garrigus Building, the Environmental Quality Management Building, and the University Drive Parking Garage. These structures will be demolished to make way for the new hospital expansion, the new CUP, and parking garage.

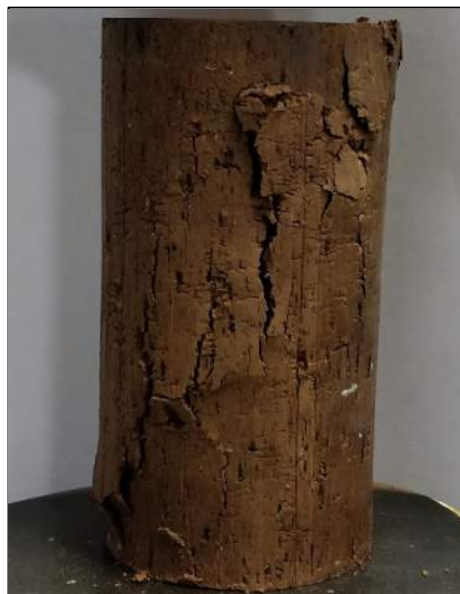
## Unconfined Compressive Strength

## Failed Specimen

Type of Sample: IntactSource of Moisture Sample: EntireLiquid Limit: 43Plasticity Index: 22Height to Diameter Ratio: 2.0Rate of Strain (%/min.): 1Strain at Failure: 1.4%Initial Dry Unit Weight: 95.8 pcf Initial Water Content: 22.0%Unconfined Compressive Strength,  $q_u$ : **4451** PSFUndrained Shear Strength,  $s_u$ : **2225** PSF

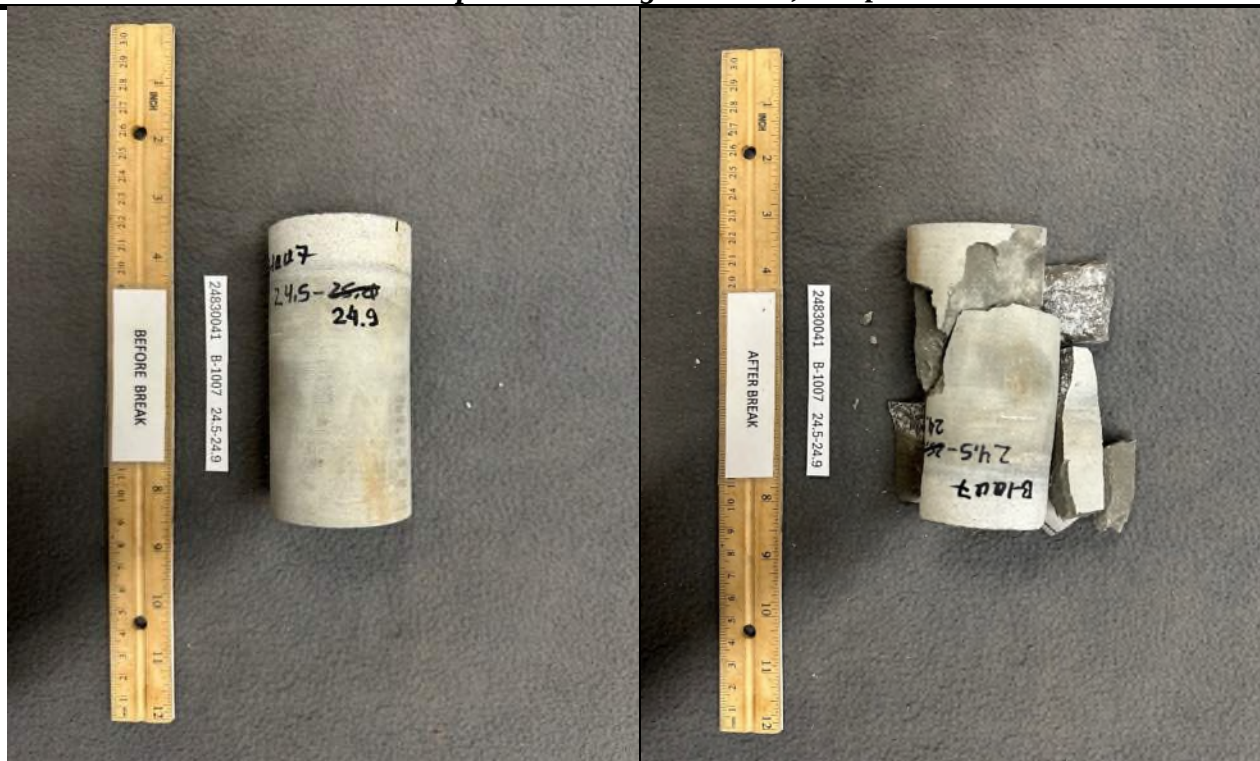
Moisture Content 1.0 % Dry Unit Weight 163.9 pcf  
Compressive Strength 10,223 psi

Before Test

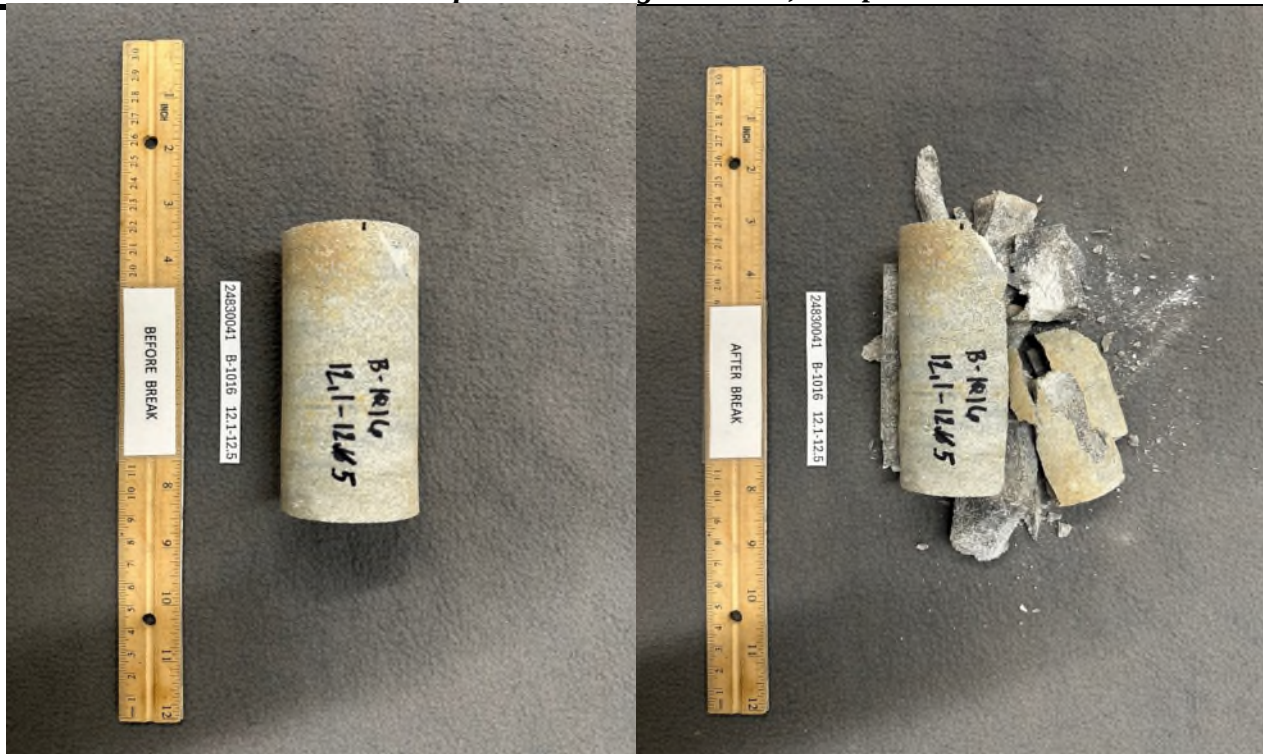
**Test Results****Moisture Content****0.8 %****Dry Unit Weight****159.4 pcf****Compressive Strength****12,225 psi**

**Before Test****After Test**

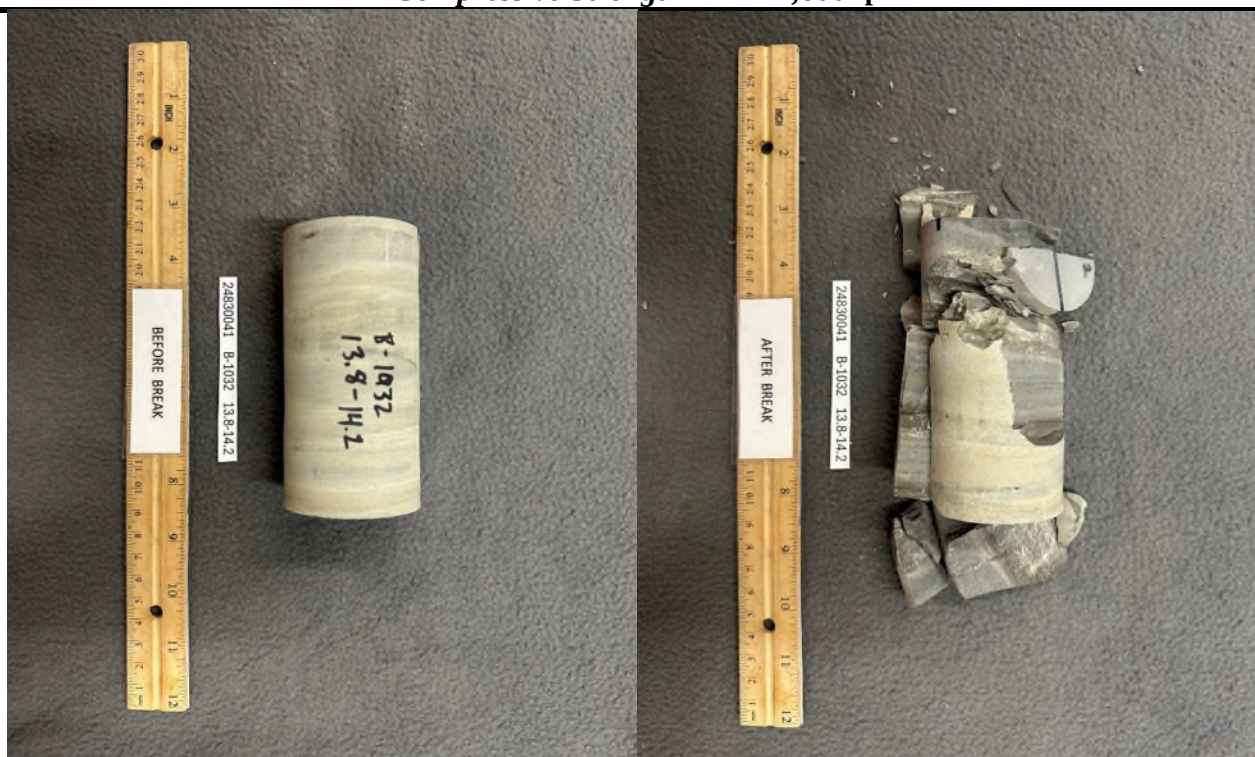
**Test Results****Moisture Content****0.9 %****Dry Unit Weight****158.1 pcf****Compressive Strength****11,600 psi**

**Before Test****After Test**
