University of Kentucky

Kroger Field 2027 Repairs

Concrete & Waterproofing

UK Project #3187.30

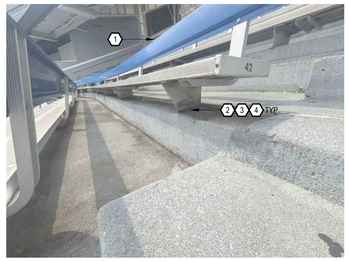
2 / 301 PHOTO DETAIL

LOWER BOWL SEAT BLEACHER BASE REPAIR

1. CATALOG ALL SEATS BY METHODS THAT ARE NOT VISIBLE AND WILL NOT DAMAGE THE ALUMINUM OR COMPONENTS.
2. PHOTO AND VIDEO DOCUMENT ALL SEATS PRIOR TO REMOVAL TO DOCUMENT ANY DAMAGE, INCLUDING BLEACHERS/SEATS IN OTHER AREAS OF THE STADIUM WHERE STORAGE MAY OCCUR.
3. AT EACH ROW AND SECTION OF BLEACHERS, MEASURE AND DOCUMENT THE LOCATION OF BLEACHERS TO ENSURE INSTALLATION AT THE SAME LOCATION RELATIVE TO HEIGHT AND THE HORIZONTAL PLACEMENT FROM THE WALL OR AISLE.
4. CONTRACTOR OPTION TO SALVAGE OR REPLACE WITH MATCHING THE ALUMINUM BLEACHER PLANK SPLICES. PROVIDE NEW RIVETS WHEN BLEACHERS ARE REINSTALLED.
5. REINSTALL THE BLEACHERS AFTER ALL WORK IS COMPLETED IN THE LOWER BOWL AREA.
6. REFER TO PHOTO DETAILS 2/301 AND 3/301 FOR BLEACHER BASE REPAIRS.

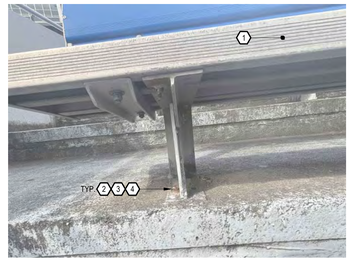
3 / 301 PHOTO DETAIL

LOWER BOWL SEAT BLEACHER BASE REPAIR

1. REMOVE AND REINSTALL BLEACHERS IN ALL ROWS IN THE LOWER BOWL SEATING PER PHOTO DETAIL 1/301.
2. CUT FLUSH WITH THE CONCRETE ALL BLEACHER ANCHORS AND EPOXY/URETHANE OVERCOAT. REFER TO SPECIFICATION SECTION 099100.
3. AFTER MEMBRANE INSTALLATION AND AS PART OF BLEACHER WORK, INSTALL NEW STAINLESS STEEL THREADED RODS WITH MATCHING NUT AT THE BLEACHERS SUPPORTS IMMEDIATELY HORIZONTALLY ADJACENT TO THE ORIGINAL ANCHORS. EPOXY EMBED THE THREADED ROD 3". REFER TO SPECIFICATION SECTION 055000.
4. ASSUME INSTALLATION OF 2 NEW ANCHORS PER EACH BLEACHER BASE.

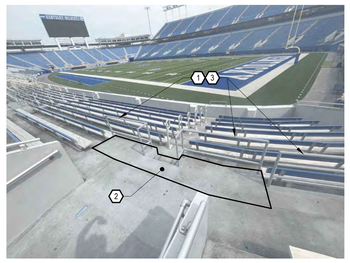
5 / 301 PHOTO DETAIL

LOWER BOWL VOMITORY BASE RAILS

1. PREPARE RAILS AND INSTALL A NEW HIGH PERFORMANCE COATING SYSTEM. REFER TO SPECIFICATION SECTION 099100.
2. PERFORM CONCRETE REBUILD OF LANDING. REFER TO DETAIL 11/401.
3. RESET RAIL INTO LANDING AS PART OF CONCRETE REPAIR.

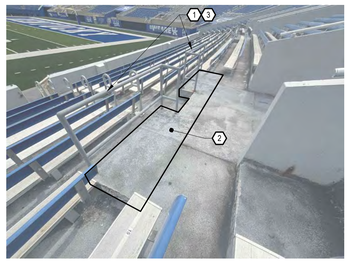
6 / 301 PHOTO DETAIL

LOWER BOWL VOMITORY BASE RAILS

1. CATALOG AISLE RAIL POSTS BY METHODS THAT ARE NOT VISIBLE AND WILL NOT DAMAGE THE RAIL OR COATING.
2. AT EACH ROW AND SECTION, MEASURE AND DOCUMENT THE LOCATION OF THE RAIL POSTS TO ENSURE INSTALLATION AT THE SAME LOCATION RELATIVE TO HEIGHT AND THE HORIZONTAL PLACEMENT FROM THE WALL OR AISLE.
3. SALVAGE AND PROTECT ALL POST ANCHORS.
4. AFTER MEMBRANE INSTALLATION, INSTALL NEW STAINLESS STEEL THREADED RODS WITH MATCHING NUT AT THE SEAT SUPPORTS IMMEDIATELY HORIZONTALLY ADJACENT TO THE ORIGINAL ANCHORS. EPOXY EMBED THE THREADED ROD 3". REFER TO SPECIFICATION SECTION 055000.
5. REINSTALL THE AISLE RAIL POSTS.

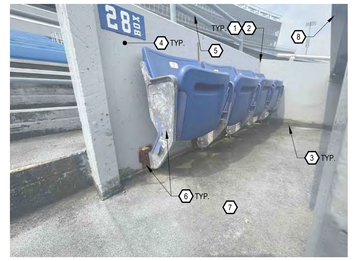
11 / 301 PHOTO DETAIL

VOMITORY HANDRAIL ANCHOR REPLACEMENT

1. ALONG THE NESTED SEATING WALLS, REMOVE AND REPLACE THE VERTICAL SEALANT JOINTS UP 6" AT THE TWO FACES WITH URETHANE. REFER TO DETAIL 5/501.
2. ALONG THE NESTED SEATING WALLS, REMOVE AND REPLACE THE VERTICAL SEALANT JOINTS ABOVE 6" AT THE SIDE WALLS (BOTH FACES) AND TOPSIDE OF THE WALL WITH SILICONE. REFER TO DETAIL 5/501.

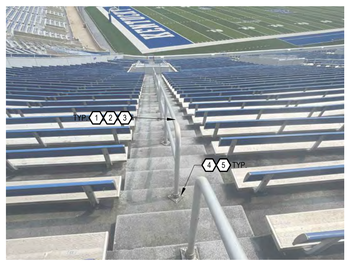
21 / 302 **PHOTO DETAIL**

LOWER BOWL SIDE WALLS REPAIRS

1. CATALOG ALL AISLE RAILS BY METHODS THAT ARE NOT VISIBLE AND WILL NOT DAMAGE THE ALUMINUM.
2. PHOTO AND VIDEO DOCUMENT ALL RAILS PRIOR TO REMOVAL TO DOCUMENT ANY DAMAGE.
3. AT EACH RAIL, MEASURE AND DOCUMENT THE LOCATION TO ENSURE INSTALLATION AT THE SAME LOCATION.
4. REMOVAL INCLUDES THE EXISTING BASE SHOE AND ANCHORS. CLEAN OFF ALL EXISTING COATING FROM BASE SHOES PRIOR TO REINSTALLATION.
5. AFTER MEMBRANE INSTALLATION, INSTALL THE BASES AND RAILS UTILIZING NEW STAINLESS STEEL THREADED RODS WITH MATCHING NUT. EPOXY EMBED THE THREADED ROD 3". REFER TO SPECIFICATION SECTION 055000.

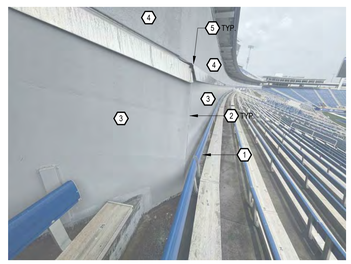
22 / 302 **PHOTO DETAIL**

LOWER BOWL AISLE RAILS

1. EXPANSION JOINT BETWEEN THE BACK WALL AND SEATING UNIT OF THE LOWER BOWL. REFER TO DETAIL 12/601 FOR WATERPROOFING REPAIRS.
2. REMOVE AND REPLACE THE VERTICAL SEALANT JOINTS AT THE EXTERIOR FACE OF THE WALL WITH SILICONE ABOVE THE EXPANSION JOINT TURN-UP. REFER TO DETAIL 5/501.
3. PREPARE AND INSTALL NEW CONCRETE HIGH PERFORMANCE OVERCOATING AT THE WALL ABOVE THE EXPANSION JOINT TURN-UP. REFER TO SPECIFICATION SECTION 099100.
4. PREPARE AND INSTALL NEW HIGH-PERFORMANCE COATING AT THE STUCCO WALL. REFER TO SPECIFICATION SECTION 099100.
5. PERFORM FLASHING REPAIRS ON TIME AND MATERIAL BASIS. THE CONTRACTOR TO INCLUDE A $10,000 ALLOWANCE IN THE BID FOR FLASHING REPAIRS.

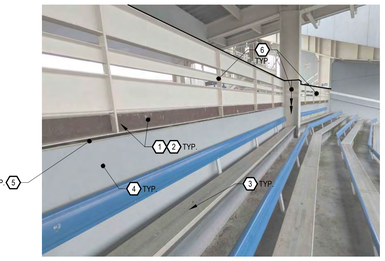
23 / 302 **PHOTO DETAIL**

LOWER BOWL BACK WALL REPAIRS

1. STEEL SLAB EDGE PLATE TO BE PREPARED AND OVERCOATED PER THE EAST AND WEST ENDZONE REPAIRS.
2. INSTALL SUPPLEMENTAL ANCHORS AT EACH RAIL POST PER THE EAST AND WEST ENDZONE REPAIRS.
3. INSTALL NEW URETHANE COVE SEALANT AT THE WALL TO SEAT UNIT INTERFACE PER THE PLAN NOTES. REFER TO DETAIL 3/501.
4. EXISTING CEMENTITIOUS WALL PANEL. PREPARE AND INSTALL NEW CONCRETE HIGH PERFORMANCE OVERCOATING AT THE WALL ABOVE THE 4" MEMBRANE TURN-UP. REFER TO SPECIFICATION SECTION 099100.
5. REFER TO DETAIL 32/403 FOR WALL FLASHING INSTALLATION AT THE RAIL BASE TO CEMENTITIOUS WALL PANEL.
6. ALTERNATE NO. 3: STEEL RAIL (BOTH SIDES) AND COLUMNS BELOW THE LINE SHOWN TO BE PREPARED AND A NEW EPOXY/URETHANE HIGH PERFORMANCE OVERCOATING INSTALLED. REFER TO SPECIFICATION SECTION 099100.

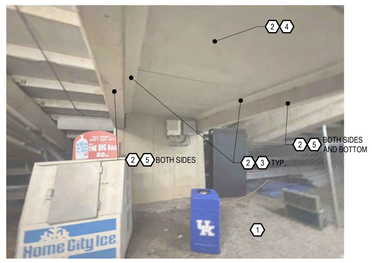
25 / 303 **PHOTO DETAIL**

LOWER BOWL TUNNEL OVERCOATING REPAIRS

1. REPAIRS IN THE LOWER BOWL TUNNEL. CONTRACTOR TO COORDINATE REPAIRS TIMEFRAME WITH THE UNIVERSITY.
2. EXISTING VOMITORY STRUCTURED WALKWAY ABOVE.
3. VOMITORY SLAB STEEL SUPPORT ANGLES TO BE PREPARED AND A NEW EPOXY/URETHANE HIGH PERFORMANCE OVERCOATING INSTALLED. REFER TO SPECIFICATION SECTION 099100.
4. VOMITORY CONCRETE SLAB SOFFIT TO BE PREPARED AND INSTALL NEW CONCRETE HIGH PERFORMANCE OVERCOATING. REFER TO SPECIFICATION SECTION 099100.
5. CONCRETE VOMITORY WALL PANEL VERTICAL SURFACE TO BE PREPARED AND INSTALL NEW CONCRETE HIGH PERFORMANCE OVERCOATING. REFER TO SPECIFICATION SECTION 099100.

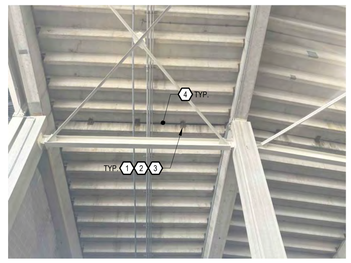
26 / 303 **PHOTO DETAIL**

LOWER BOWL TUNNEL OVERCOATING REPAIRS

1. EXPANSION JOINT BETWEEN SEATING ROWS 43 AND 44.
2. EXISTING STEEL SUPPORTS FOR ROW 44 TO BE REVIEWED WITH THE ENGINEER.
3. EXPANSION JOINT STEEL SUPPORTS TO BE PREPARED AND A NEW EPOXY/URETHANE HIGH PERFORMANCE OVERCOATING INSTALLED. REFER TO SPECIFICATION SECTION 099100.
4. UNIT PRICE: INSTALL LOWER BOWL EXPANSION JOINT SUPPLEMENTAL STEEL SUPPORT AS INSTRUCTED BY ENGINEER. REFER TO DETAIL 15/402.

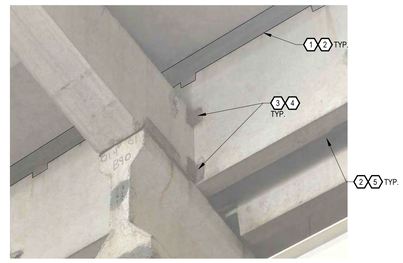
27 / 303 **PHOTO DETAIL**

LOWER BOWL EXPANSION JOINT SUPPORTS

1. CONTINUOUS ANGLE SUPPORTING THE FRONT ROW PRECAST SEATING UNIT OF THE LOGE LEXUS CLUB. PREPARE AND INSTALL NEW HIGH PERFORMANCE OVERCOATING AT THE CONTINUOUS ANGLE. REFER TO SPECIFICATION SECTION 099100.

2. CONTRACTOR TO INSPECT THE CONTINUOUS ANGLE CONNECTION FOR DEGRADATION. REPORT ANY DETERIORATED SECTIONS OF ANGLE TO THE ENGINEER.
3. DOUBLE CONNECTION BETWEEN THE CONCRETE RAKER BEAM AND LOFT SEATING AREA FRONT ROW WALL PANEL. PREPARE AND INSTALL NEW STEEL HIGH PERFORMANCE OVERCOATING AT THE DOUBLE CONNECTION ON EACH SIDE OF THE RAKER BEAM. REFER TO SPECIFICATION SECTION 099100.

4. UNIT PRICE: REPAIR RAKER BEAM TO WALL PANEL CONNECTION AS INSTRUCTED BY ENGINEER. REFER TO DETAIL 21/402.
5. CONTINUOUS ANGLE SUPPORTING THE BACK ROW PRECAST SEATING UNIT OF THE LOWER BOWL. PRECAST SEATING UNIT OF THE LOWER BOWL. PREPARE AND INSTALL NEW HIGH-PERFORMANCE OVERCOATING AT THE CONTINUOUS ANGLE. REFER TO DETAIL 24/402.

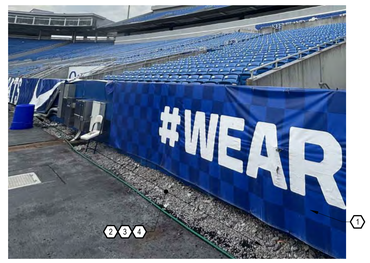
29 / 303 **PHOTO DETAIL**

PRECAST SEATING UNIT END CONNECTION REPAIR

1. THE UNIVERSITY WILL REMOVE AND REINSTALL THE BANNER ALONG THE FRONT WALL OF THE LOWER BOWL.
2. SURVEY FRONT WALL OF LOWER BOWL FOR CONCRETE DETERIORATION AND PERFORM CONCRETE VERTICAL REPAIRS PER DETAIL 3/401.
3. WATER JET LOOSE RUST AND DEBRIS BELOW BEARING OF THE WALL PANELS.
4. CLEAN STEEL PLATES BELOW FRONT WALL BEARING AND INSTALL HIGH-PERFORMANCE COATING. REFER TO SPECIFICATION SECTION 099100.
5. INSTALL NON-SHRINK CEMENTITIOUS GROUT UNDER THE WALL BASES. REFER TO SPECIFICATION SECTION 030100.
6. UNIT PRICE: WHERE NOTED BY THE ENGINEER, INSTALL SUPPLEMENTAL STEEL BRACKET AT THE WALL PANELS ANCHORED TO THE COLUMN. REFER TO DETAIL 10/401.
7. PREPARE AND COAT THE CONCRETE COLUMNS (3 SIDES) AND WALL PANEL WITH A CONCRETE HIGH-PERFORMANCE COATING. REFER TO SPECIFICATION SECTION 099100.

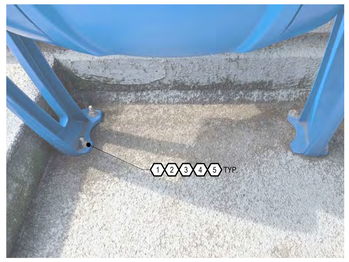
32 / 304 PHOTO DETAIL

LOWER BOWL SEAT REPAIR

1. CATALOG ALL SEATS BY METHODS THAT ARE NOT VISIBLE AND WILL NOT DAMAGE THE PLASTIC OR COMPONENTS.
2. PHOTO AND VIDEO DOCUMENT ALL SEATS PRIOR TO REMOVAL TO DOCUMENT ANY DAMAGE, INCLUDING BLEACHERS/SEATS IN OTHER AREAS OF THE STADIUM WHERE STORAGE MAY OCCUR.
3. EXISTING ANCHORS TO REMAIN. PROVIDE PROTECTING DURING REPAIRS NOT TO DAMAGE THREAD OR COAT THREADS FOR REINSTALLATION.
4. IMMEDIATELY AFTER SEAT REMOVAL AND PRIOR TO OTHER WORK, SUBMIT DOCUMENTATION TO THE ENGINEER OF ANY DAMAGED ANCHORS. CONTRACTOR SHALL ASSUME REPLACEMENT OF (100) ANCHORS IN THE BASE BID UTILIZING STAINLESS STEEL ANCHOR ROD/HARDWARE WITH AN EPOXY EMBEDMENT OF 4 1/2". ANCHORS DAMAGED DURING REPAIRS WILL BE THE RESPONSIBILITY OF THE CONTRACTOR.
5. REINSTALL THE SEATS.

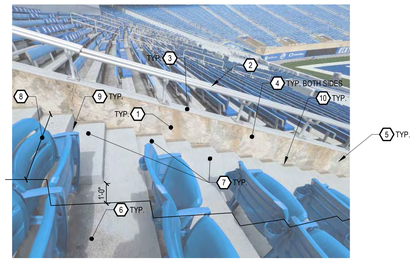
33 / 304 PHOTO DETAIL

LOWER BOWL SEAT REPAIR

1. SURVEY SIDE WALLS FOR CONCRETE DETERIORATION. PERFORM CONCRETE REPAIRS PER DETAILS ON DRAWING 401.
2. EXISTING TOP MOUNT ALUMINUM RAIL TO REMAIN IN PLACE. REFER TO PHOTO DETAIL 41/304.

4. EXISTING CONCRETE WALL SURFACE. PREPARE SURFACE AND INSTALL NEW SEALER. PERFORM WALL PREPARATION IN A MANNER NOT TO DAMAGE ADJACENT SURFACE AND MIGRATE PREPARATION MATERIALS INTO THE OCCUPIED SPACED BELOW. REFER TO SPECIFICATION SECTION 071910.

5. EXISTING SEALANT JOINTS BETWEEN WALL PANELS. REMOVE AND REPLACE WITH SILICONE SEALANT. REFER TO DETAIL 5/501.
6. PREPARE MEMBRANE SURFACE, AND INSTALL MEDIUM DUTY RECOAT IN TYPICAL AREAS OF THE LOWER BOWL CENTRAL AREA. REFER TO DETAILS ON DRAWING 601.

7. AS PART OF THIS PROJECT, THE CONTRACTOR IS TO REMOVE THE CAST-IN-PLACE TREAD IN EACH SEATING ROW AS NOTED ON THE PLANS.
8. AS NOTED ON THE PLAN AT THE AISLE ALONG THE SIDE WALLS, REMOVE THE EXISTING MEMBRANE AND INSTALL A NEW HEAVY DUTY MEMBRANE SYSTEM. REFER TO DETAILS ON DRAWING 601.

9. PERFORM HORIZONTAL ISOLATION JOINT SEALANT REPLACEMENT BETWEEN PRECAST SEATING UNIT TO PRECAST SEATING UNITS WHERE MEMBRANE IS BEING REMOVED. REFER TO DETAIL 5/501. INSTALL MEMBRANE DETAIL COAT WITH NO REINFORCING AS PART OF MEMBRANE WORK PER DETAIL 10/601.

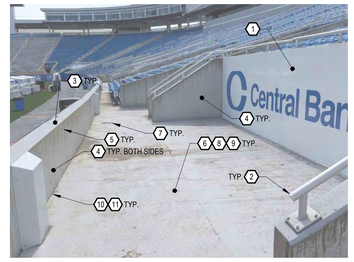
34 / 304 PHOTO DETAIL

LOWER BOWL SIDE WALL REPAIRS

1. EXISTING WALL GRAPHIC. DO NOT DAMAGE.
2. EXISTING TOP MOUNT ALUMINUM RAIL TO REMAIN IN PLACE. REFER TO PHOTO DETAIL 41/304 FOR REPAIRS.
3. EXISTING CONCRETE WALL PANEL. PREPARE TOP SURFACE AND INSTALL CEMENTITIOUS BASED CONCRETE WATERPROOFING. BASIS OF DESIGN IS MIRACOTE MPC, 2 COAT APPLICATION. COLOR SELECTION BY THE OWNER. CONTRACTOR TO PROVIDE A MOCK-UP (1'-0" BY 1'-0" OF THREE STANDARD COLORS OF THE MIRACOTE MPC PRIOR TO BEGINNING THE WORK.

4. EXISTING CONCRETE WALL SURFACE. PREPARE SURFACE AND INSTALL NEW SEALER. PERFORM WALL PREPARATION IN A MANNER NOT TO DAMAGE ADJACENT SURFACE AND MIGRATE PREPARATION MATERIALS INTO THE OCCUPIED SPACED BELOW. REFER TO SPECIFICATION SECTION 071910.

5. EXISTING SEALANT JOINTS BETWEEN WALL PANELS. REMOVE AND REPLACE WITH SILICONE SEALANT. REFER TO DETAIL 5/501.
6. AS NOTED ON THE PLAN AT THE FRONT VOMITORIES AND WALKWAY, REMOVE THE EXISTING MEMBRANE AND INSTALL A NEW HEAVY DUTY MEMBRANE SYSTEM. REFER TO DETAILS ON DRAWING 601.

7. REMOVE AND REPLACE THE SEALANT AT THE DRAIN BODY. REFER TO DETAIL 6/501.
8. UNIT PRICE: REMOVE AND REPLACE THE TOOLED JOINT SEALANTS. REFER TO DETAIL 2/501.

9. UNIT PRICE: REMOVE AND REPLACE SEALANT AT SLAB CRACKS. REFER TO DETAIL 1/501.
10. REMOVE AND REPLACE ALL COVE SEALANT. REFER TO DETAIL 3/501.
11. AT ALL CONCRETE WALLS, PROVIDE MEMBRANE TURN-UP. REFER TO DETAIL 3/601.

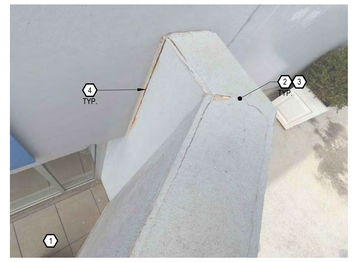
42 / 304 PHOTO DETAIL

LOWER BOWL BACK LANDING AND WALL REPAIRS

1. REFER TO PHOTO DETAIL ON DRAWING 351 FOR PATIO WORK.
2. UNIT PRICE: PERFORM STUCCO WALL REPAIRS. REFER TO DETAIL 36/403.
3. UPON COMPETITION OF STUCCO WALL REPAIRS, PREPARE SURFACES AND INSTALL A HIGH PERFORMANCE COATING. REFER TO SPECIFICATION SECTION 099100.
4. INSTALL NEW OVERSIZED SILICONE COVE SEALANT BETWEEN THE STUCCO WALL AND CONCRETE WALL. REFER TO DETAIL 4/501.

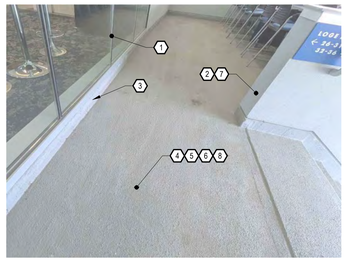
1 / 311 PHOTO DETAIL

LOGE LEXUS CLUB FRONT ROW REPIARS ABOVE

1. EXISTING METAL PANEL WALL AND GLASS WALL SYSTEM ALONG THE INTERIOR OF THE LOGE LEXUS CLUB. DO NOT DAMAGE.
2. EXISTING METAL STUD WALL WITH STUCCO FINISH. DO NOT DAMAGE.
3. EXISTING WATERPROOFING TURN-UP BELOW THE METAL PANEL WALL, GLASS WALL, AND METAL STUD WALL. COMPLETELY REMOVE EXISTING MEMBRANE FOR NEW WATERPROOFING SYSTEM.
4. REMOVE ALL EXISTING MEMBRANE IN THE LOGE LEXUS CLUB INCLUDING SLABS/TREADS, RISERS, WALKWAYS, STEPS, AND CURBS.
5. PREPARE CONCRETE SURFACE AND INSTALL NEW HEAVY DUTY TRAFFIC BEARING MEMBRANE IN ALL AREAS OF THE LOGE LEXUS CLUB. REFER TO DETAILS ON DRAWINGS 601.
6. LOGE LEXUS CLUB MEMBRANE TO INCLUDE A 4" TURN-UP AT ALL WALLS AND CURBS. REFER TO DETAIL 3/601.
7. PREPARE STUCCO WALLS AND INSTALL OVERCOATING SYSTEM UPON COMPLETION OF WORK. REFER TO SPECIFICATION SECTION 099100.
8. REFER TO PLAN NOTES FOR CONCRETE AND SEALANT WORK AT THE SLAB.

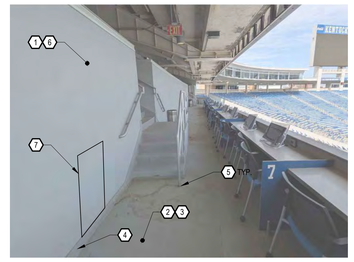
2 / 311 PHOTO DETAIL

LOGE LEXUS CLUB PASSENGER ELEVATOR AT STAIR

1. EXISTING METAL STUD WALL WITH STUCCO FINISH. DO NOT DAMAGE.
2. REMOVE ALL EXISTING MEMBRANE IN THE LOGE LEXUS CLUB INCLUDING SLABS/TREADS, RISERS, WALKWAYS, STEPS, AND CURBS.
3. PREPARE CONCRETE SURFACE AND INSTALL NEW HEAVY DUTY TRAFFIC BEARING MEMBRANE IN ALL AREAS OF THE LOGE LEXUS CLUB. REFER TO DETAILS ON DRAWINGS 601.
4. LOGE LEXUS CLUB MEMBRANE TO INCLUDE A 4" TURN-UP AT ALL WALLS AND CURBS. REFER TO DETAIL 3/601.
5. DO NOT TURN-UP MEMBRANE ON RAIL POSTS AND THE PASSENGER LIFT SYSTEM. TERMINATE MEMBRANE IMMEDIATELY ADJACENT TO THE POST OR EQUIPMENT. UPON CURE OF MEMBRANE, PREPARE SURFACE AND INSTALL SILICONE COVE SEALANT. REFER TO DETAIL 3/501.
6. PREPARE STUCCO WALLS AND INSTALL OVERCOATING SYSTEM UPON COMPLETION OF WORK. REFER TO SPECIFICATION SECTION 099100.
7. REFER TO PLAN NOTES FOR CONCRETE AND SEALANT WORK AT THE SLAB.

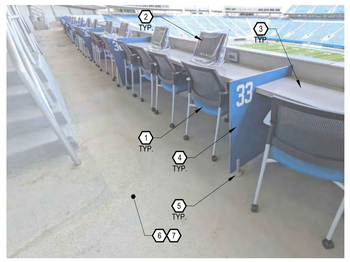
4 / 311 PHOTO DETAIL

LOGE LEXUS CLUB STAIR AND WALL ACCESS PANELS

1. ALL EXISTING CHAIRS TO BE TEMPORARILY REMOVED AND REINSTALLED BY THE UNIVERSITY.
2. ALL EXISTING COMPUTERS TO BE TEMPORARILY REMOVED AND REINSTALLED BY THE UNIVERSITY.
3. EXISTING COUNTER TO BE PROTECTED BY THE CONTRACTOR.
4. EXISTING PANEL TO BE PROTECTED BY THE CONTRACTOR AND TEMPORARILY SUPPORTED FOR MEMBRANE INSTALLATION BELOW.
5. TEMPORARILY REMOVE PANEL POST SUPPORT AND REINSTALL AFTER MEMBRANE WORK.
6. REMOVE ALL EXISTING MEMBRANE IN THE LOGE LEXUS CLUB INCLUDING SLABS/TREADS, RISERS, WALKWAYS, STEPS, AND CURBS.
7. PREPARE CONCRETE SURFACE AND INSTALL NEW HEAVY DUTY TRAFFIC BEARING MEMBRANE IN ALL AREAS OF THE LOGE LEXUS CLUB. REFER TO DETAILS ON DRAWINGS 601.

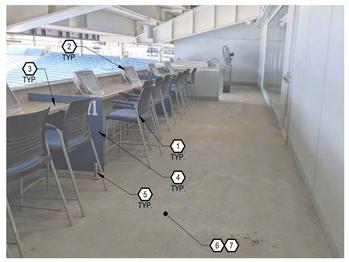
5 / 311 PHOTO DETAIL

LOGE LEXUS CLUB COUNTER LOWER SEATING AREA

1. ALL EXISTING CHAIRS TO BE TEMPORARILY REMOVED AND REINSTALLED BY THE UNIVERSITY.
2. ALL EXISTING COMPUTERS TO BE TEMPORARILY REMOVED AND REINSTALLED BY THE UNIVERSITY.
3. EXISTING COUNTER TO BE PROTECTED BY THE CONTRACTOR.
4. EXISTING PANEL TO BE PROTECTED BY THE CONTRACTOR AND TEMPORARILY SUPPORTED FOR MEMBRANE INSTALLATION BELOW.
5. TEMPORARILY REMOVE PANEL POST SUPPORT AND REINSTALL AFTER MEMBRANE WORK.
6. REMOVE ALL EXISTING MEMBRANE IN THE LOGE LEXUS CLUB INCLUDING SLABS/TREADS, RISERS, WALKWAYS, STEPS, AND CURBS.
7. PREPARE CONCRETE SURFACE AND INSTALL NEW HEAVY DUTY TRAFFIC BEARING MEMBRANE IN ALL AREAS OF THE LOGE LEXUS CLUB. REFER TO DETAILS ON DRAWINGS 601.

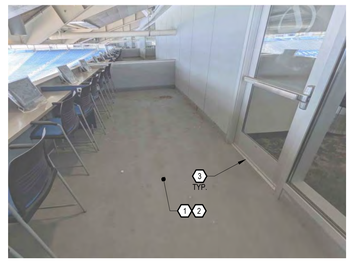
6 / 311 PHOTO DETAIL

LOGE LEXUS CLUB COUNTER UPPER SEATING AREA

1. REMOVE ALL EXISTING MEMBRANE IN THE LOGE LEXUS CLUB INCLUDING SLABS/TREADS, RISERS, WALKWAYS, STEPS, AND CURBS.
2. PREPARE CONCRETE SURFACE AND INSTALL NEW HEAVY DUTY TRAFFIC BEARING MEMBRANE IN ALL AREAS OF THE LOGE LEXUS CLUB. REFER TO DETAILS ON DRAWINGS 601.
3. EXISTING THRESHOLD INTO THE LOGE LEXUS CLUB INTERIOR SPACE. REMOVE EXISTING DOOR THRESHOLD, STOP NEW SLAB MEMBRANE UNDER THRESHOLD, AND REINSTALL THE THRESHOLD IN A FULL BED SILICONE SEALANT WITH STAINLESS STEEL ANCHORS. REFER TO SPECIFICATION SECTION 079200.

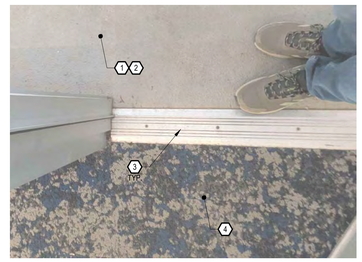
7 / 311 PHOTO DETAIL

LOGE LEXUS CLUB INTERIOR DOOR THRESHOLD

1. REMOVE ALL EXISTING MEMBRANE IN THE LOGE LEXUS CLUB INCLUDING SLABS/TREADS, RISERS, WALKWAYS, STEPS, AND CURBS.
2. PREPARE CONCRETE SURFACE AND INSTALL NEW HEAVY DUTY TRAFFIC BEARING MEMBRANE IN ALL AREAS OF THE LOGE LEXUS CLUB. REFER TO DETAILS ON DRAWINGS 601.
3. EXISTING THRESHOLD INTO THE LOGE LEXUS CLUB INTERIOR SPACE. REMOVE EXISTING DOOR THRESHOLD, STOP NEW SLAB MEMBRANE UNDER THRESHOLD, AND REINSTALL THE THRESHOLD IN A FULL BED SILICONE SEALANT WITH STAINLESS STEEL ANCHORS. REFER TO SPECIFICATION SECTION 079200.
4. INTERIOR CARPET AT THE LOGE LEXUS CLUB. PROTECT FROM DAMAGE.

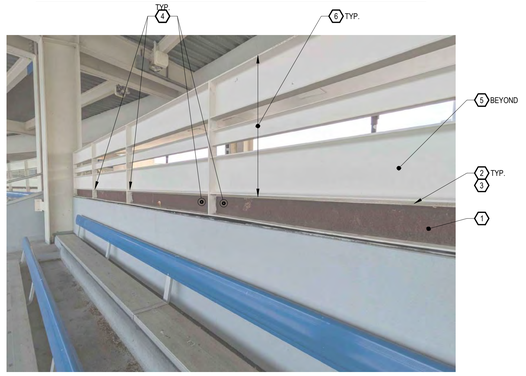
26/324 **PHOTO DETAIL**

END ZONE UPPER CONCOURSE CONCRETE & WATERPROOFING REPAIRS

1. PREPARE THE OUTSIDE FACE OF SLAB EDGE PLATE AND OVERCOAT WITH A HIGH PERFORMANCE COATING. REFER TO SPECIFICATION SECTION 099100.
2. GRIND GROOVE ALONG THE EDGE OF THE PLATE PRIOR TO MEMBRANE INSTALLATION. REFER TO DETAIL 2/601.
3. PREPARE THE TOP AND INSIDE FACE AT GROOVE OF SLAB EDGE PLATE AND OVERCOAT WITH A HIGH PERFORMANCE COATING. INSTALL PENETRATING PRIMER AT THE SLAB EDGE PRIOR TO THE FULL OVERCOATING SYSTEM. REFER TO SPECIFICATION SECTION 099100.
4. INSTALL SUPPLEMENTAL STEEL ANCHORS AT SLAB EDGE PLATE AT EACH VERTICAL RAIL PLATE POST. REFER TO DETAIL 33/403.
5. INSTALL NEW CONCOURSE HEAVY DUTY MEMBRANE PER PHOTO DETAILS 17/323 AND 18/323.
6. ALTERNATE NO. 3: PREPARE THE SIDE RAIL OF THE CONCOURSE AND OVERCOAT WITH A HIGH-PERFORMANCE COATING. REFER TO PHOTO DETAILS 27/324 AND 28/324.

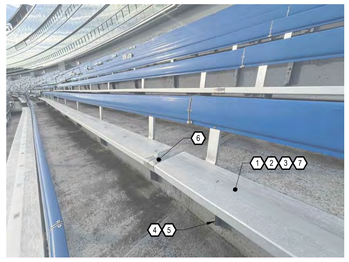
1/331 PHOTO DETAIL

UPPER BOWL BLEACHER REPAIRS

1. CATALOG ALL SEATS BY METHODS THAT ARE NOT VISIBLE AND WILL NOT DAMAGE THE ALUMINUM OR COMPONENTS.
2. PHOTO AND VIDEO DOCUMENT ALL SEATS PRIOR TO REMOVAL TO DOCUMENT ANY DAMAGE, INCLUDING BLEACHERS/SEATS IN OTHER AREAS OF THE STADIUM WHERE STORAGE MAY OCCUR.

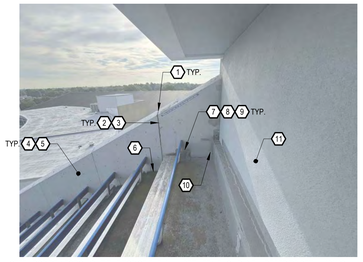
7/331 PHOTO DETAIL

UPPER BOWL BACK WALL REPAIRS

1. UNIT PRICE: INSTALL STEEL ROD REINFORCING AT THE TOP OF THE WALL BETWEEN PANELS AS INSTRUCTED BY ENGINEER. REFER TO DETAIL 18/402.
2. REMOVE AND REPLACE THE VERTICAL SEALANT JOINTS 6" AT THE INTERIOR FACE OF THE WALL WITH URETHANE. REFER TO DETAIL 5/501.

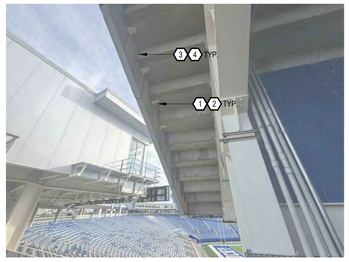
9/331 PHOTO DETAIL

UPPER BOWL SIDE WALLS REPAIRS

1. REFER TO PHOTO DETAIL 8/331 AND 9/331 FOR TOPSIDE REPAIRS ALONG THE SIDE WALLS.
2. ALONG THE SIDE WALLS OF THE UPPER BOWL AREA AT ROWS 1 THROUGH 10 ONLY, PREPARE STEEL BRACKETS/ANGLES TO SSPC-SP6 CONDITION, AND INSTALL AN EPOXY/URETHANE HIGH PERFORMANCE OVERCOATING. REFER TO SPECIFICATION SECTION 099100.
3. UNIT PRICE: AS DIRECTED BY THE ENGINEER, INSTALL WALL TO RISER TOP ANGLE CONNECTIONS AT ROWS 1 TO 28. REFER TO DETAIL 27/403.
4. UNIT PRICE: AS DIRECTED BY THE ENGINEER, INSTALL WALL TO SLAB BOTTOM ANGLE CONNECTIONS AT ROWS 1 TO 28. REFER TO DETAIL 28/403.

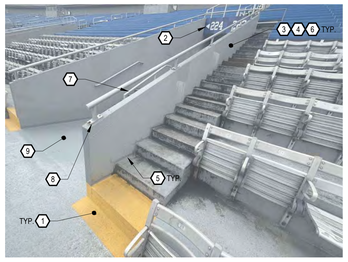
10/331 PHOTO DETAIL

UPPER BOWL SIDE WALLS SOFFIT REPAIRS ROWS 1 TO 10

1. CATALOG STEPS PAINTED BY THE UNIVERSITY WITH YELLOW COATING AT THE UPPER BOWL. INSTALL MEMBRANE COLORED TOPCOAT AT ALL STEPS AS PART OF WORK. REFER TO SPECIFICATION SECTION 071800.

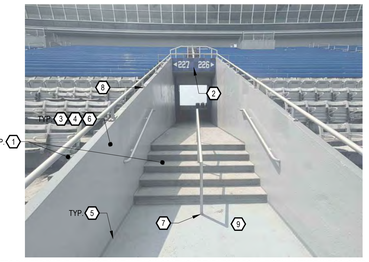
11/331 PHOTO DETAIL

UPPER BOWL REPAIRS AT THE VOMITORIES

1. CATALOG STEPS PAINTED BY THE UNIVERSITY WITH YELLOW COATING AT THE UPPER BOWL. INSTALL MEMBRANE COLORED TOPCOAT AT ALL STEPS AS PART OF WORK. REFER TO SPECIFICATION SECTION 071800.

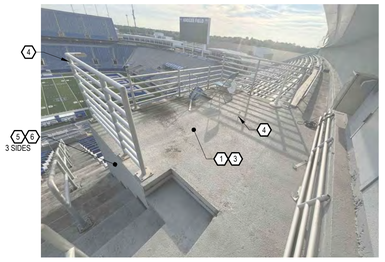
14 / 332 PHOTO DETAIL

UPPER BOWL REPAIRS AT VOMITORIES

1. AT THE VOMITORIES AND CURBS, THE CONTRACTOR RESPONSIBLE TO GRIND AND REMOVE ALL EXISTING RESIDUE AND PAST COATINGS. THIS PREPARATION IS IN ADDITION TO THE TYPICAL CONCRETE SHOTBLAST/MEDIA BLAST PREPARATION. REFER TO SPECIFICATION SECTION 071800.
2. INSTALL A HEAVY DUTY EPOXY MEMBRANE SYSTEM. REFER TO DETAILS ON DRAWING 601.
3. PROVIDE MEMBRANE TURN-UP AT THE CURB OF THE CONCOURSE WALL. REFER TO DETAIL 3/601.
4. REFER TO DETAIL 13/332 FOR OVERCOATING THE UNDERSIDE OF THE VOMITORY.
5. REFER TO DETAILS 11/331 AND 12/331 FOR OVERCOATING OF VOMITORY WALLS AND MEMBRANE INSTALLATION.

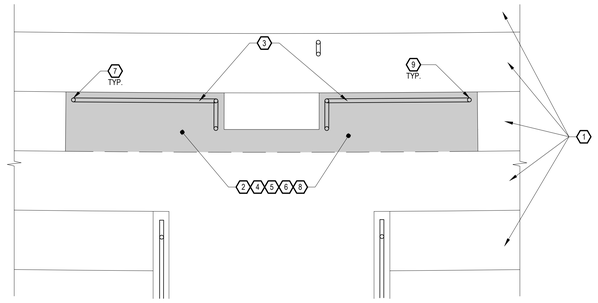
7 / 401 DETAIL

4. ASSUMED CAST-IN-PLACE TOPPING SLAB WITH FREEZE-THAW DAMAGE. CONTRACTOR SHALL ASSUME REMOVAL OF 4" OF CONCRETE OVER THE ENTIRE LANDING INCLUDING THE SIDES OF THE LANDING.

1. EXISTING PRECAST CONCRETE SEATING UNITS.
2. CAST-IN-PLACE CONCRETE VOMITORY LANDING.
3. EXISTING STEEL RAIL. PREPARE SURFACES AND INSTALL A HIGH PERFORMANCE COATING. REFER TO SPECIFICATION SECTION 099100.

6. PREPARE CONCRETE SURFACES AND NEW CONCRETER REPAIR MATERIAL. REFER TO SPECIFICATION SECTION 030100.
7. RAIL TO REMAIN SUPPORTED IN THE CONCRETE DURING THE REPAIRS. POUR NEW CONCRETE AROUND THE POSTS.
