CM SERVICES – SCOVELL HALL RENOVATION

ADDENDUM #1

# **ASBESTOS CONTAINING MATERIALS, POLYCHLORINATED BIPHENYLS IN CAULK, LEAD-BASED PAINT, & HAZARDOUS MATERIALS INSPECTION REPORT**

**University of Kentucky - Scovell Hall  
115 Huguelet Drive  
Lexington, Fayette County, Kentucky 40508**

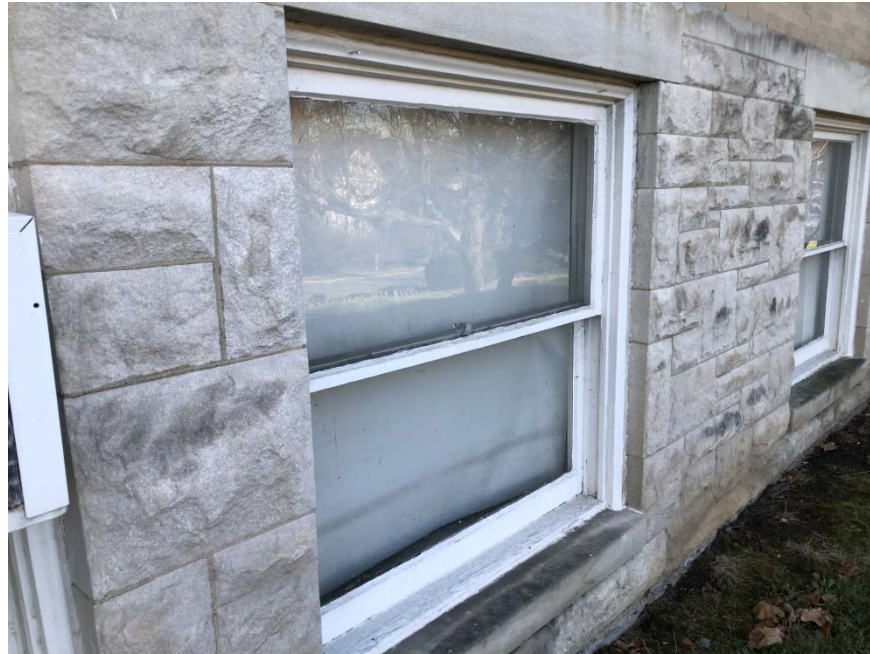
| 13 | DESCRIPTION | Example view of a wooden window located on Side B of Section 1. |

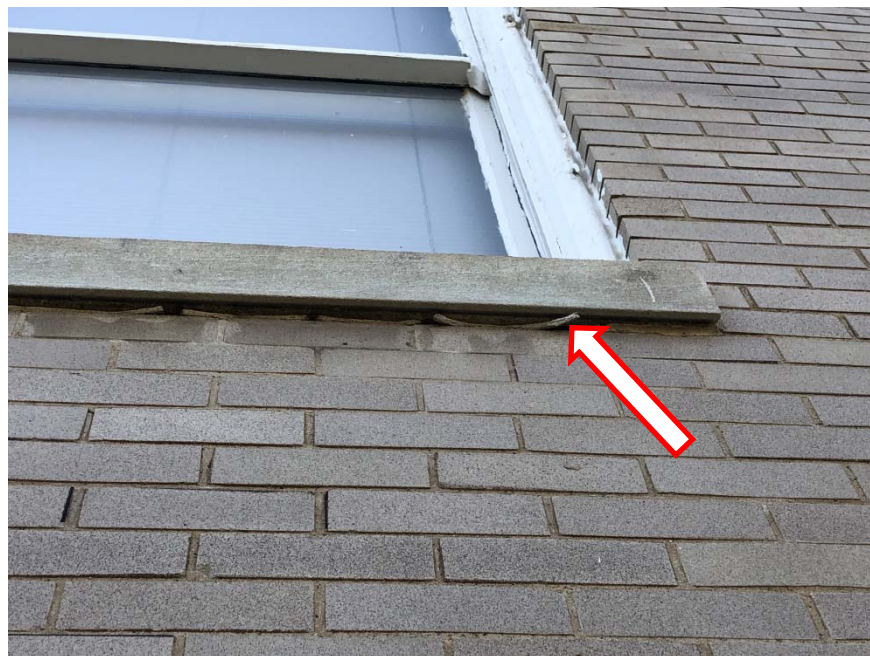
| 16 | DESCRIPTION | View of a 2 <sup>nd</sup> floor concrete window sill located on Side C of Section 3. |

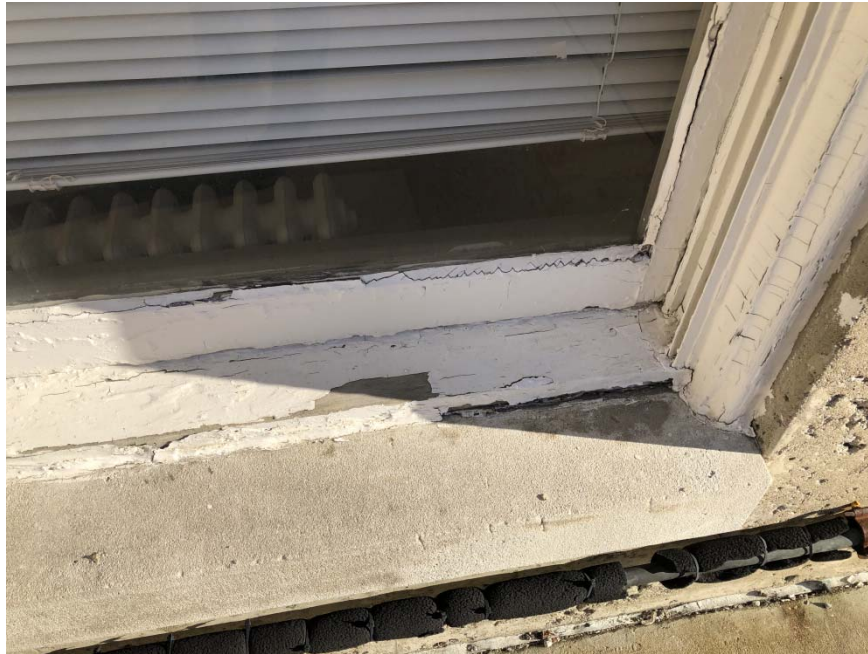
| 17 | DESCRIPTION | View of a wooden window located on Side A of Section 3 showing the positive lead-based paint, asbestos caulk & putty, and PCB caulking. |

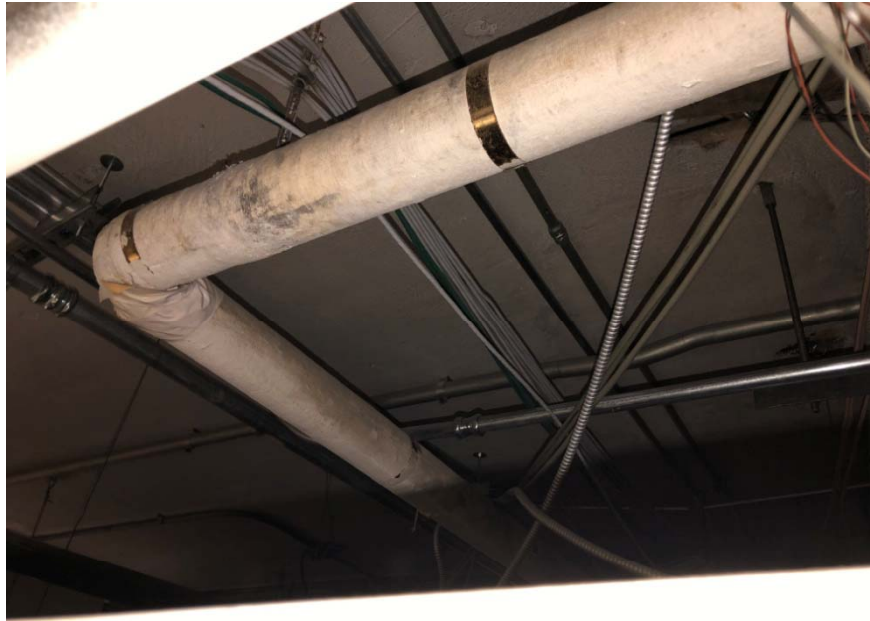
- Asbestos was historically found within the Thermal System Insulation (TSI) associated with the pipe elbows, tees, hangers, valves, and straight runs (exposed and within walls and ceilings) throughout Section 1 of the subject building in addition to the aforementioned mechanical room. All associated TSI is in friable condition and considered RACM.

| 19 | DESCRIPTION | View of the asbestos containing TSI located above the suspended ceiling within the basement of Section 1. |
