Existing Steel Framing Section View

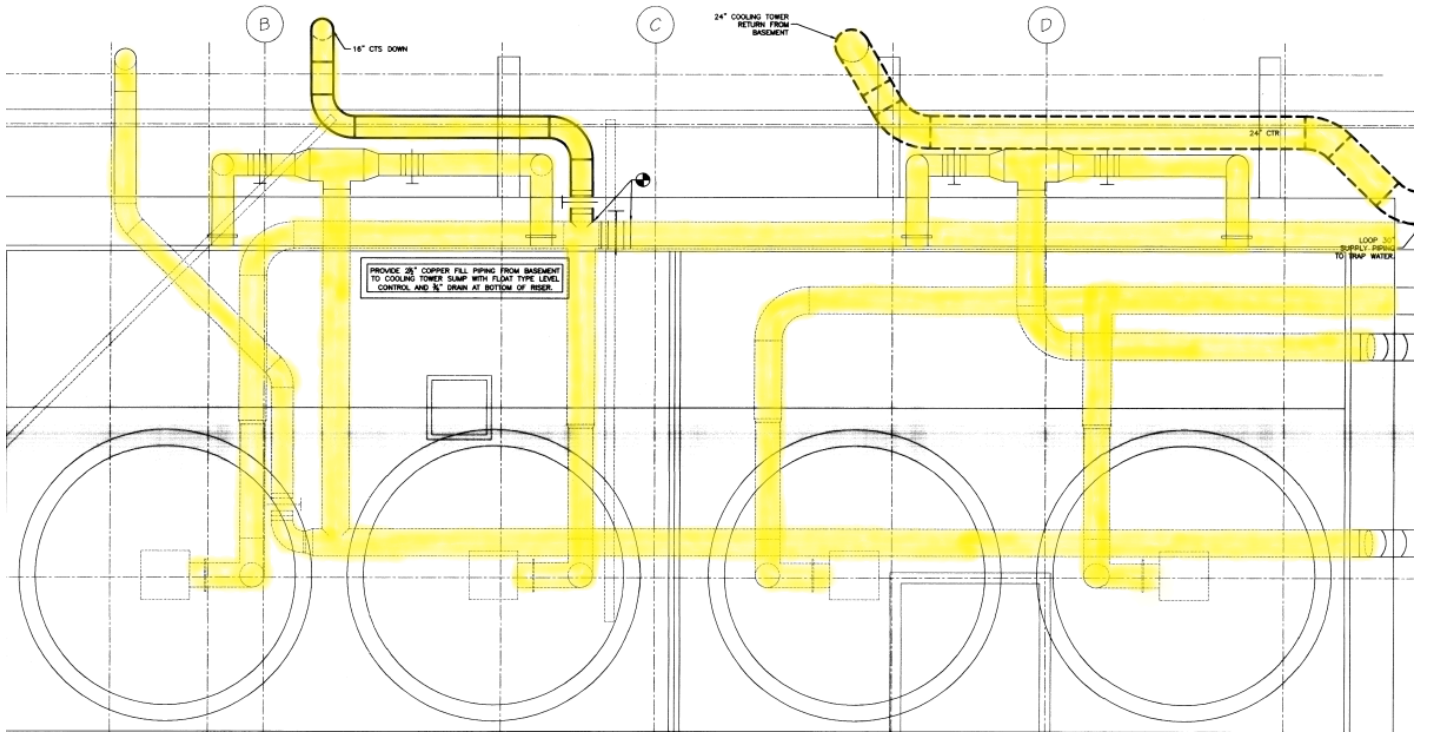
Alternate 1 – Plan View - Roof

The highlighted piping runs horizontally under the cooling towers on the roof and down the side of the building. See Alternate photo 001, 002, 003 and 004.
